BLOG – Rail Culvert Rehab using GRP Segments

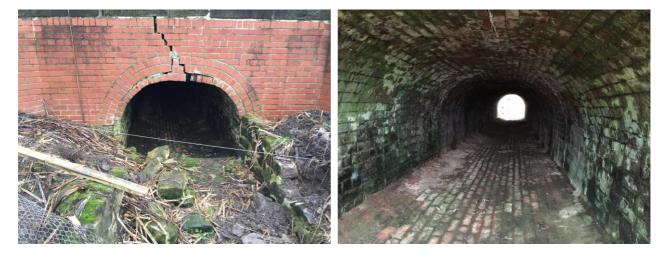
The existing 1700x1300 brick-arch culvert (located in East Cowick, Yorkshire) is 80 years old, and was in a very poor state of repair, with severe cracking, and a risk of the railway lines above the culvert collapsing. The culvert was not in use prior to the repairs being carried out, but would be re-commissioned into service upon completion of the scheme.

Working with the main contractor and Network Rail, iLine developed a cost-effective fully-structural solution and programme to repair the failing pipeline. iLine's in-house design team commenced detailed design works in December 2015, with an operational timescale of 2 weeks during March 2016. The client, together with the rail safety team both fully endorsed the overall scheme, and provided great support to iLine throughout the project.
