GRP Segmental Culvert Lining at Farthinghoe

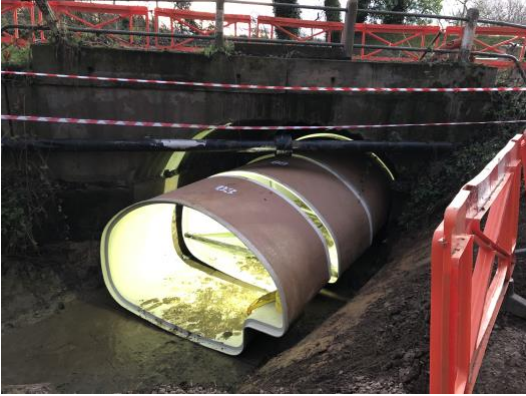
The bridge was constructed of a skew brick-arch section which had previously been repaired, but this was now failing, along with signs of radial cracking occurring. The bridge had been extended in 1971 with a corrugated steel arch which was also now showing signs of corrosion. The structure is shallow, 15m long with a flat invert and straight walls, which arches across to a height of 1816mm with a span of 3000mm.

Due to operational restraints on this structure, a GRP segmental lining process was chosen to be the most cost-effective, non-disruptive and reliable solution with over 100 years of design life. The GRP units had to be designed to be fully structural standalone units to take all the loadings imposed up to 40t using the LM2 Eurocode design specifications.
