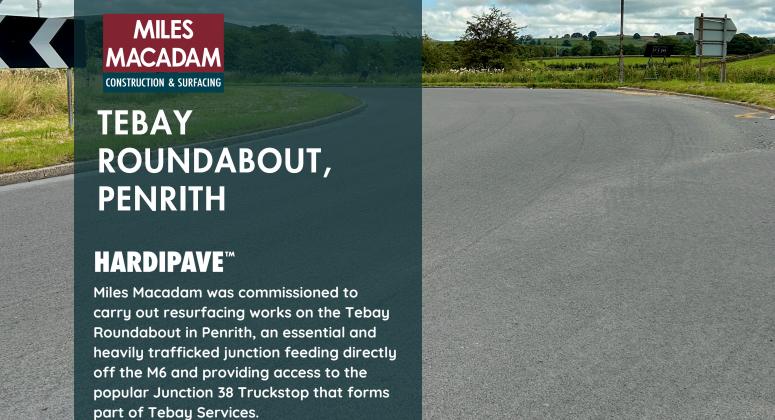
Upon inspection, the existing surface was found to be suffering from multiple signs of advanced deterioration. As well as visible cracking at the centre joints, likely caused by years of continuous heavy loading from HGVs. It also displayed widespread HRA chipping loss and rutting. These failures reinforced the need for a robust and long lasting material capable of withstanding the traffic conditions. Hardipave™ was chosen specifically for its jointless construction, which mitigates the risk of future centre joint failure and helps extend the life of the carriageway.

The resurfacing works covered approximately 2,200 m² of the roundabout, using 14 mm Hardipave™. To enhance the structural integrity of the carriageway, a 60 mm binder course was installed across the full area before the application of the surface course. This ensures both strength and flexibility, making it well suited to the demands of this route.
