OUNDLE NORTH VIADUCT

MARS INSTALLATION CASE HISTORY -2020

Client: Northampton Highways/WSP/Kier

HISTORIC THIRTEEN ARCH OUNDLE NORTH VIADUCT

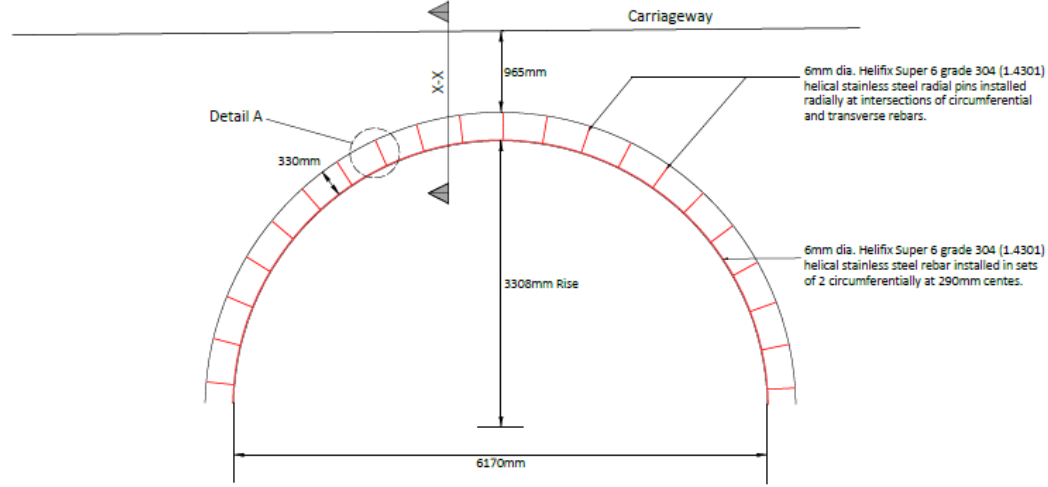
MARS STRENGTHENING DETAIL

1. Arches are numbered from West to East
2. Helical stainless steel rebar grade 1.4301 to BS EN 10088-1:2005 (304S31)
3. Rebar encapsulated in MARFLEX epoxy grout
4. Radial ties encapsulated in HellBond Grout

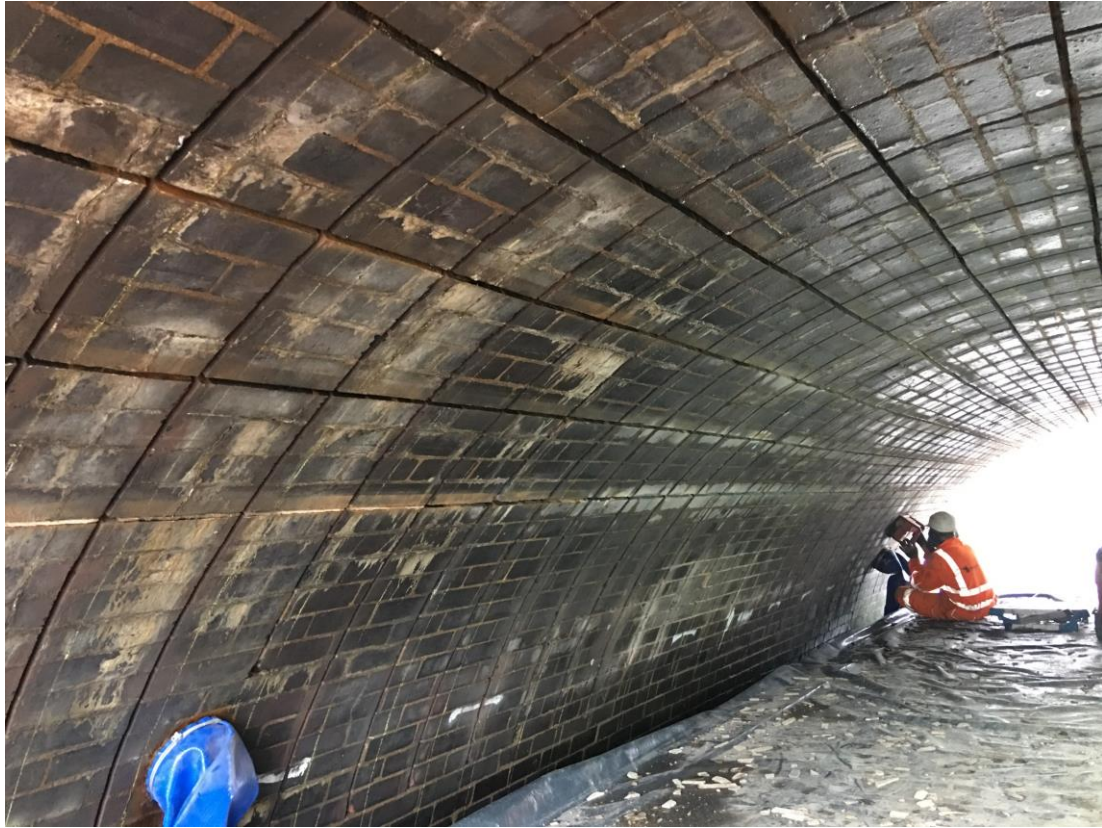
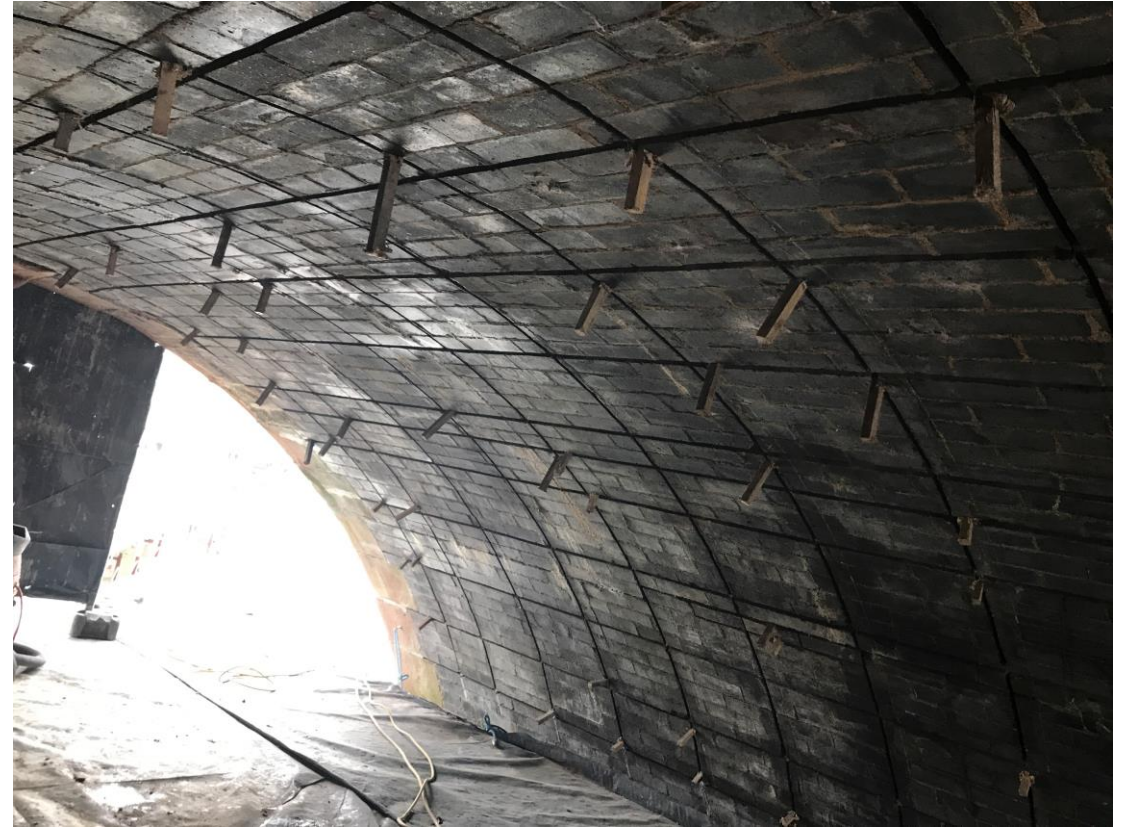
Pontoon access makes for very efficient and environmentally clean operations.
