Scour Protection
Project Spotlights

Escob Bridge

Award Winning Bridge Rehabilitation

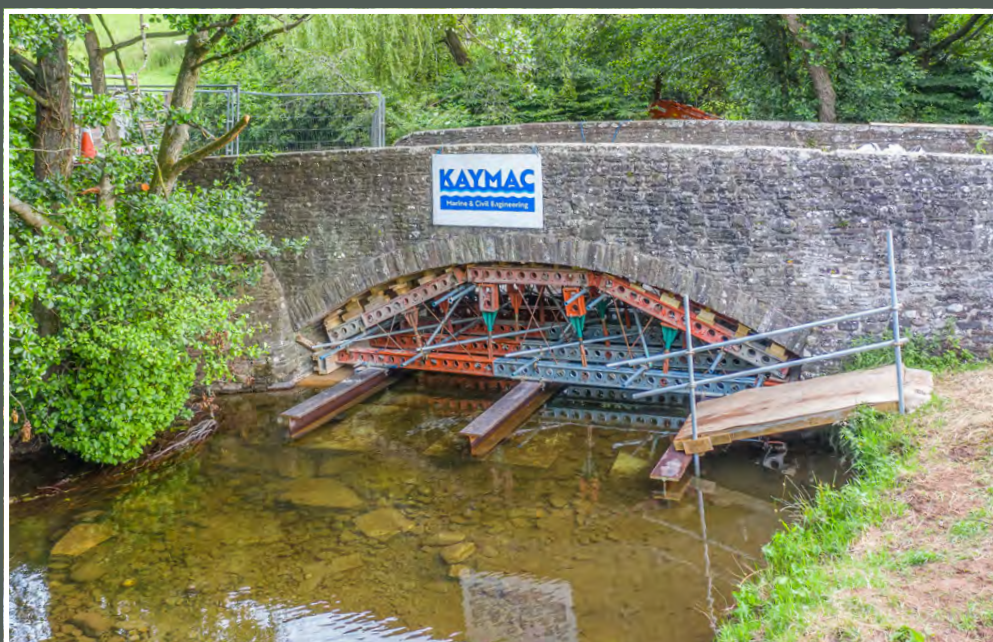
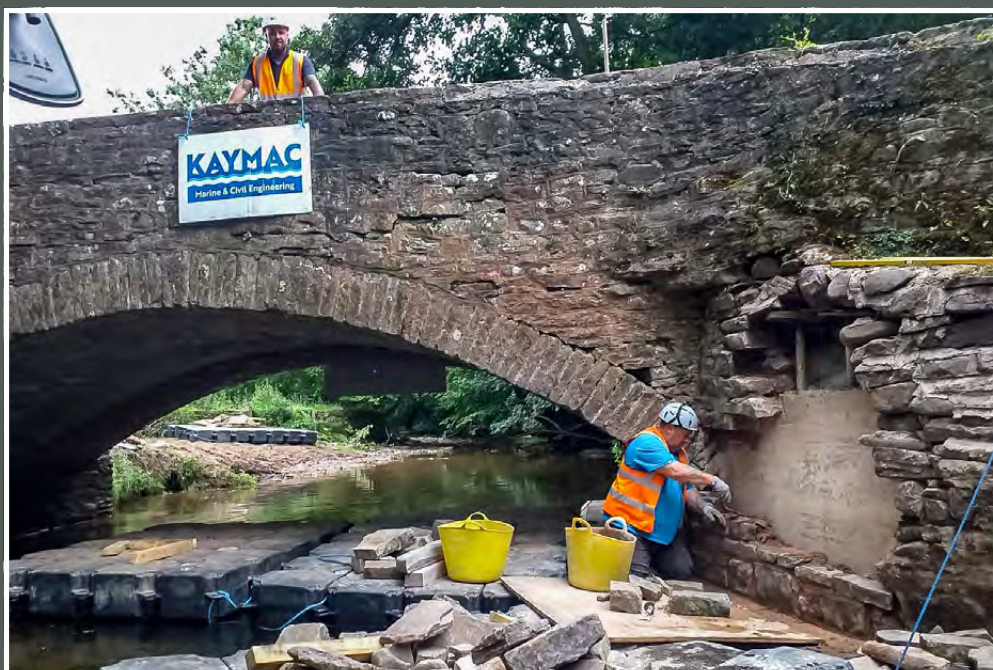
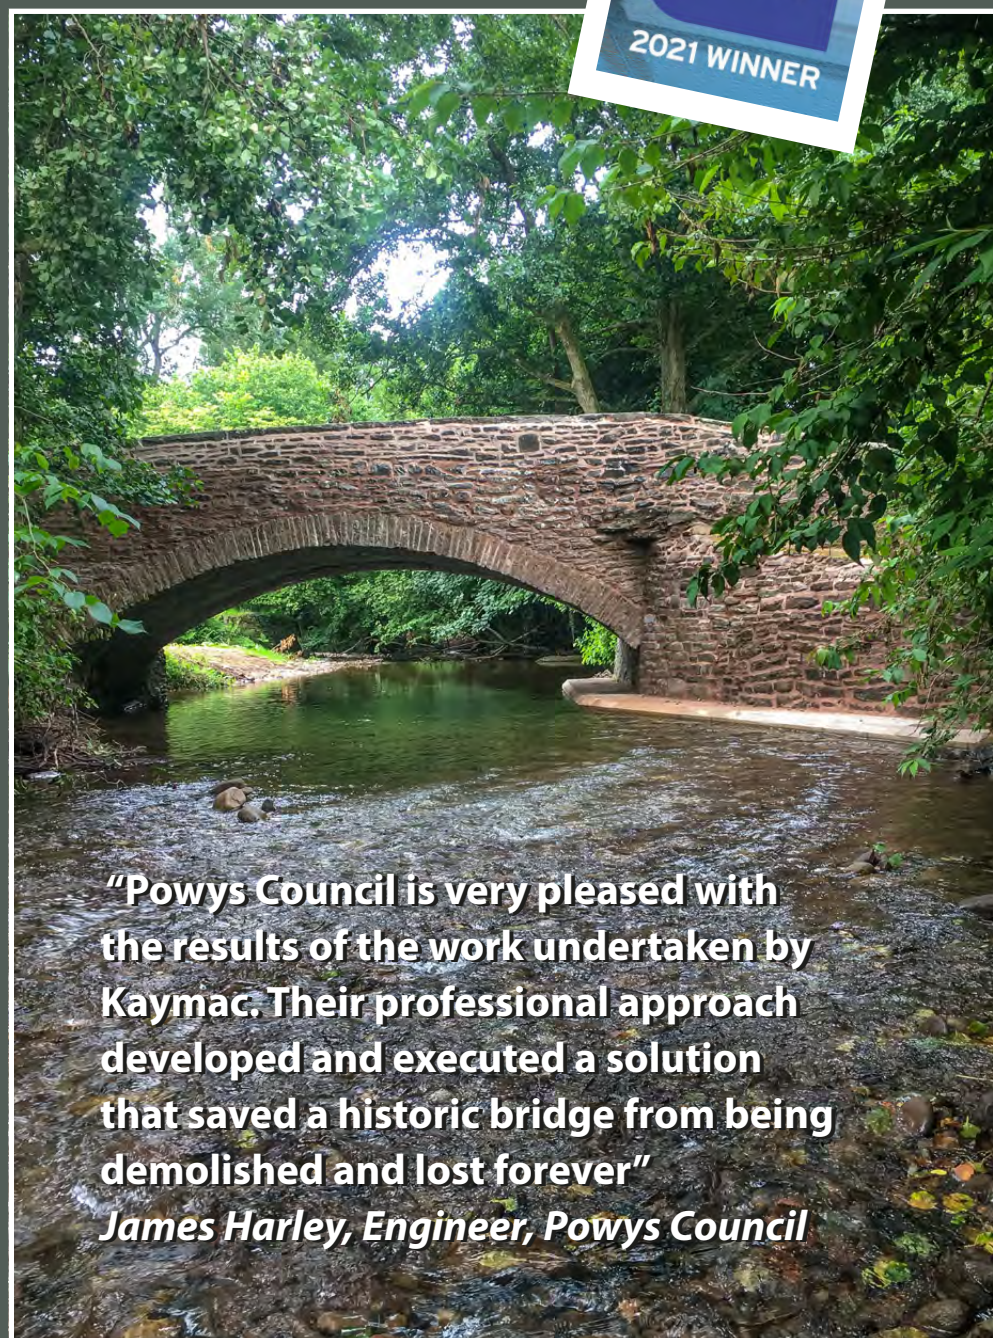
Due to the lack of structural stability, all parties were of the opinion that operative access beneath the structure to undertake any remedial works would not be safe. The extent of the flood damage to the structure's abutment was so extreme that it was clearly visible from the opposite river bank, with the arch being almost unsupported for over 50% of the abutment length. The asset owner immediately closed all vehicular and pedestrian use of the bridge.

Kaymac were originally invited to develop a safe method for demolishing and reconstructing the bridge. Not being content with this approach and being confident that we could offer an innovative solution to the client, our engineers began brainstorming possible solutions and determined that through careful control of the watercourse, a temporary composite propping system could be floated beneath the structure without the need for any operatives to be put at risk during its installation. The solution would also allow water to pass through the structure if future flooding events were to occur during the planned repair programme.

The solution would require temporary RC bases capable of withstanding the bearing pressures exerted by the propping system, being installed upstream and downstream of the structure. We consulted with our suppliers, namely RMD Kwikform and Pebble Engineering Ltd to confirm that our proposal would satisfy a detailed design, before presenting our proposal to the client. Through a stringent interview process, the proposal details were questioned and

The method of constructing and positioning the RC bases, floating the temporary propping system beneath the bridge and essentially using hydraulic jacks to raise the whole system to ensure continuous contact of the temporary works with the existing structure was achieved to ensure that under no circumstances, operatives were required to work beneath the structure and risk being injured through structural collapse during the temporary works installation.

be safely undertaken by Kaymac. Being a Grade II listed structure, Kaymac liaised with the local Heritage & Conservation Dept. of the Brecon Beacons National Park Authority to develop a suitable repair method that would not only stabilise the structure but also maintain the historic complexion of the bridge. It was agreed that a composite repair entailing in-situ concrete and masonry would be adopted in this instance. Kaymac's commercial divers safely removed the misplaced masonry from the river bed before erecting formwork to encapsulate the repair area. The concrete was installed in 3 vertical lifts from the invert to the arch springing and offset horizontally from the face of the existing abutment so that the recovered masonry could be reinstalled and tied in with the existing details. Once the structure had been stabilised and the concrete test cubes proven to be in excess of the required design strength, the formwork was dis-assembled. The temporary propping system was then safely removed to allow the safe inspection of the arch barrel and other structural elements of the bridge.

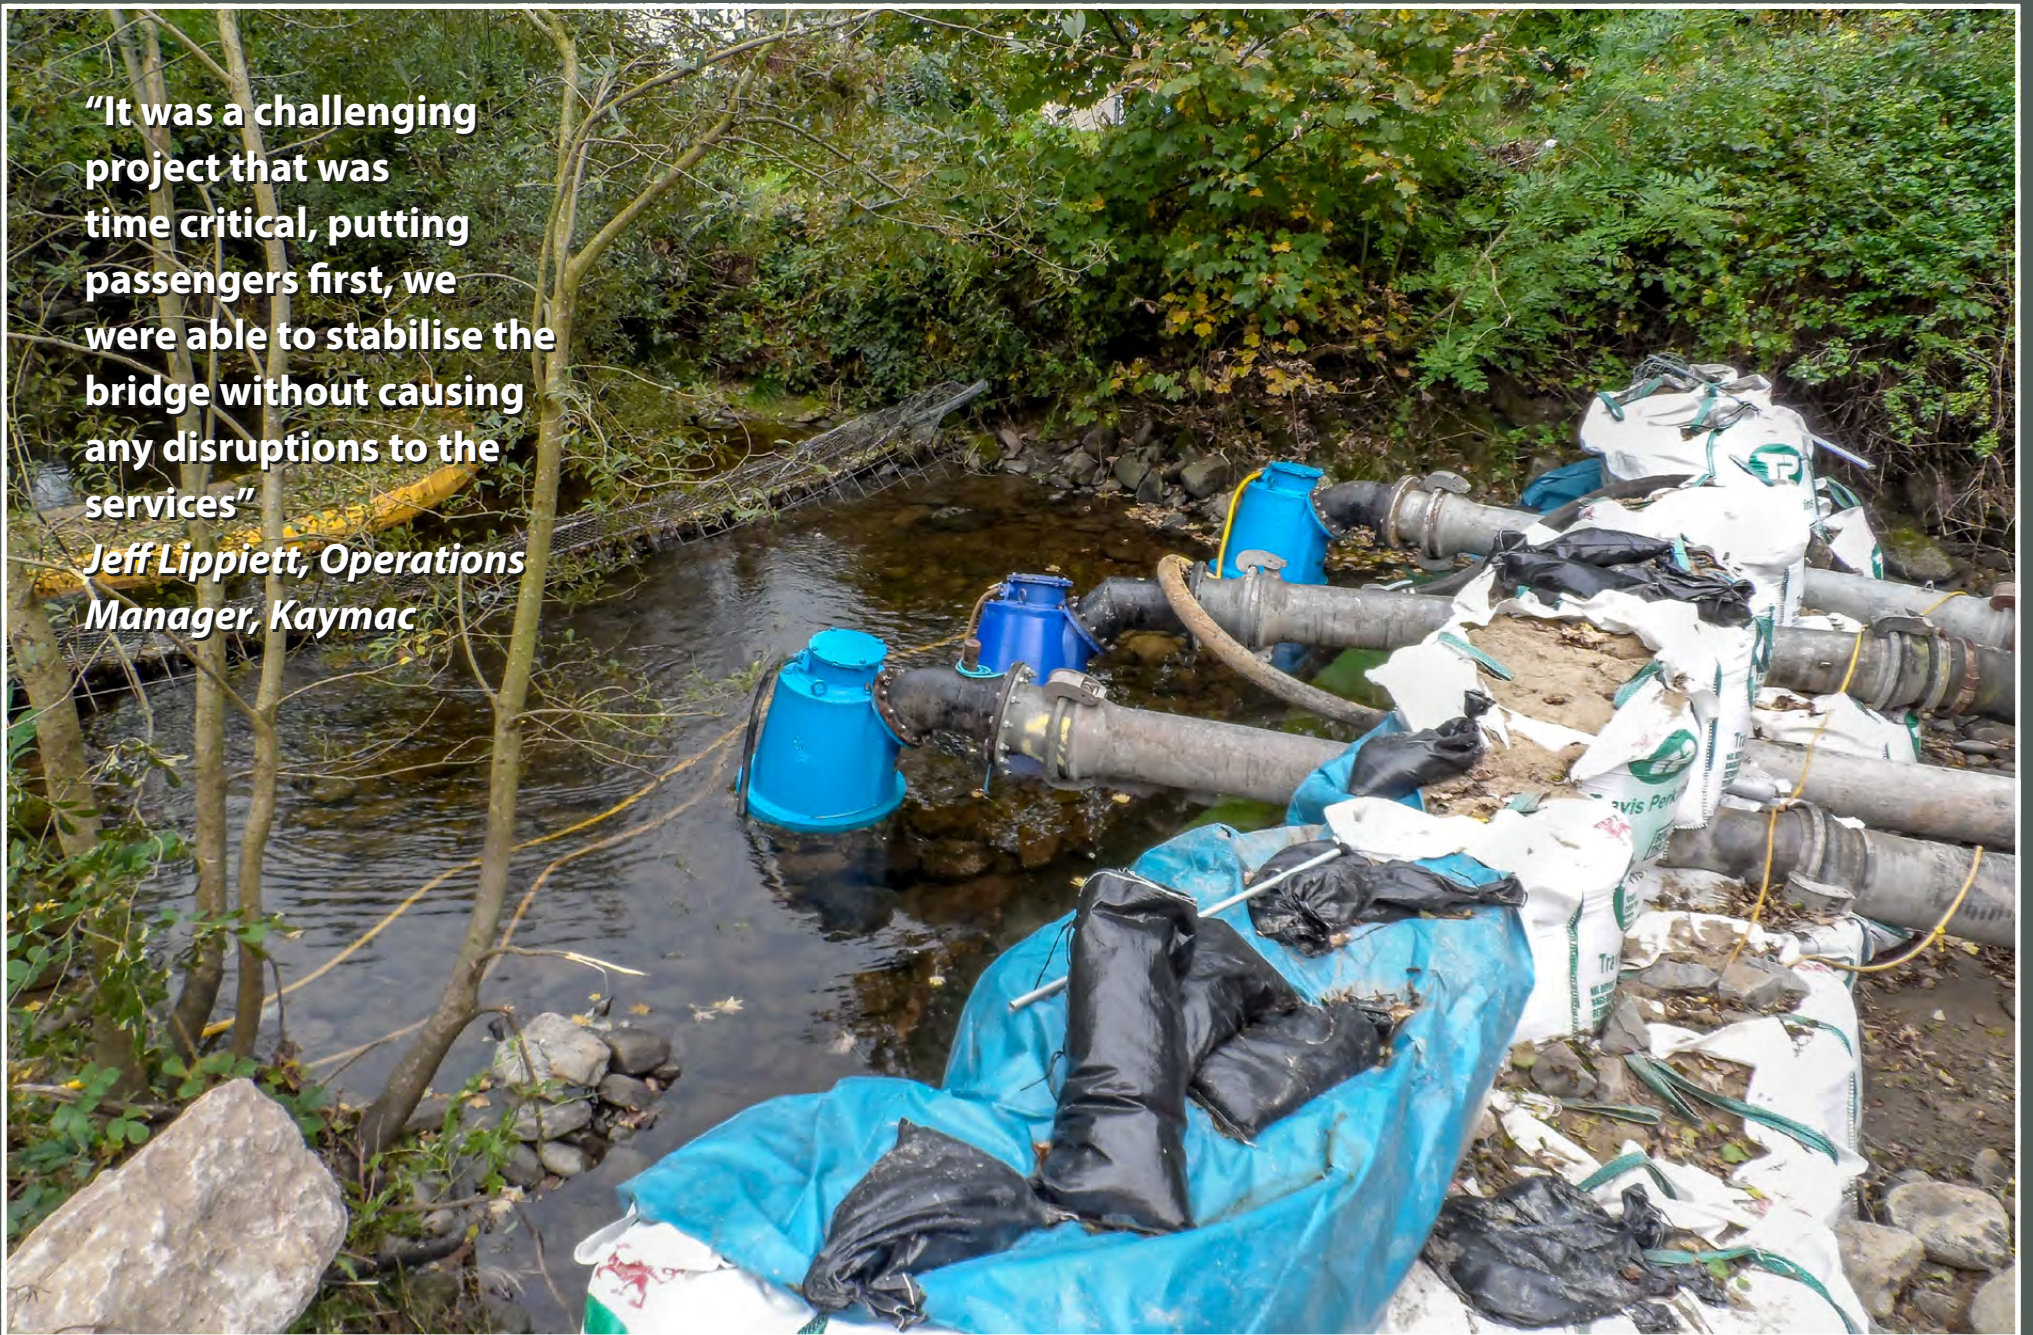
Following inspection of the under-bridge of the Afon Pandy single span masonry bridge carrying the railway line over the river Cwm from Newtown to Machynleth, it was identified that masonry repairs and improved scour protection works were required to ensure the safety of the structure

During the winter months, the river flows had damaged the various scour protection system installed by others previously. Kaymac were commissioned by Amco Rail to install a new thick reinforced concrete invert throughout the structure to protect from scour. Re-pointing and stitch drilling works were also required to the abutments and archway of the structure.

It was planned for the river to be over-pumped to ensure a dry working area for the works. A temporary sand bag bund was installed at the upstream face of the structure, with 3 No. 12" submersible pumps used to channel the flow through the structure downstream. A 12" flume was incorporated into the bund to ensure an open pass for any migratory fish.

Once installed and the working area had been de-watered, the excavation works began to remove the bed material to the formation level. The works were carried out in two halves to ensure adequate access for the excavators and dumpers. Kaymac had two teams working 12 hour shifts per day (day and night working)

The concrete was pumped into the shuttering to create the first half of the invert. As an NRW requirement, stone was placed by hand into the concrete with the aim of it helping to reduce the flows when the river was re-opened. Once the first half had cured, the above was repeated to complete the scour protection works. Plinths were also installed both upstream and downstream to protect the foundations of the structure's wing walls. The project was completed successfully during a period of very poor weather and high river flows. ●

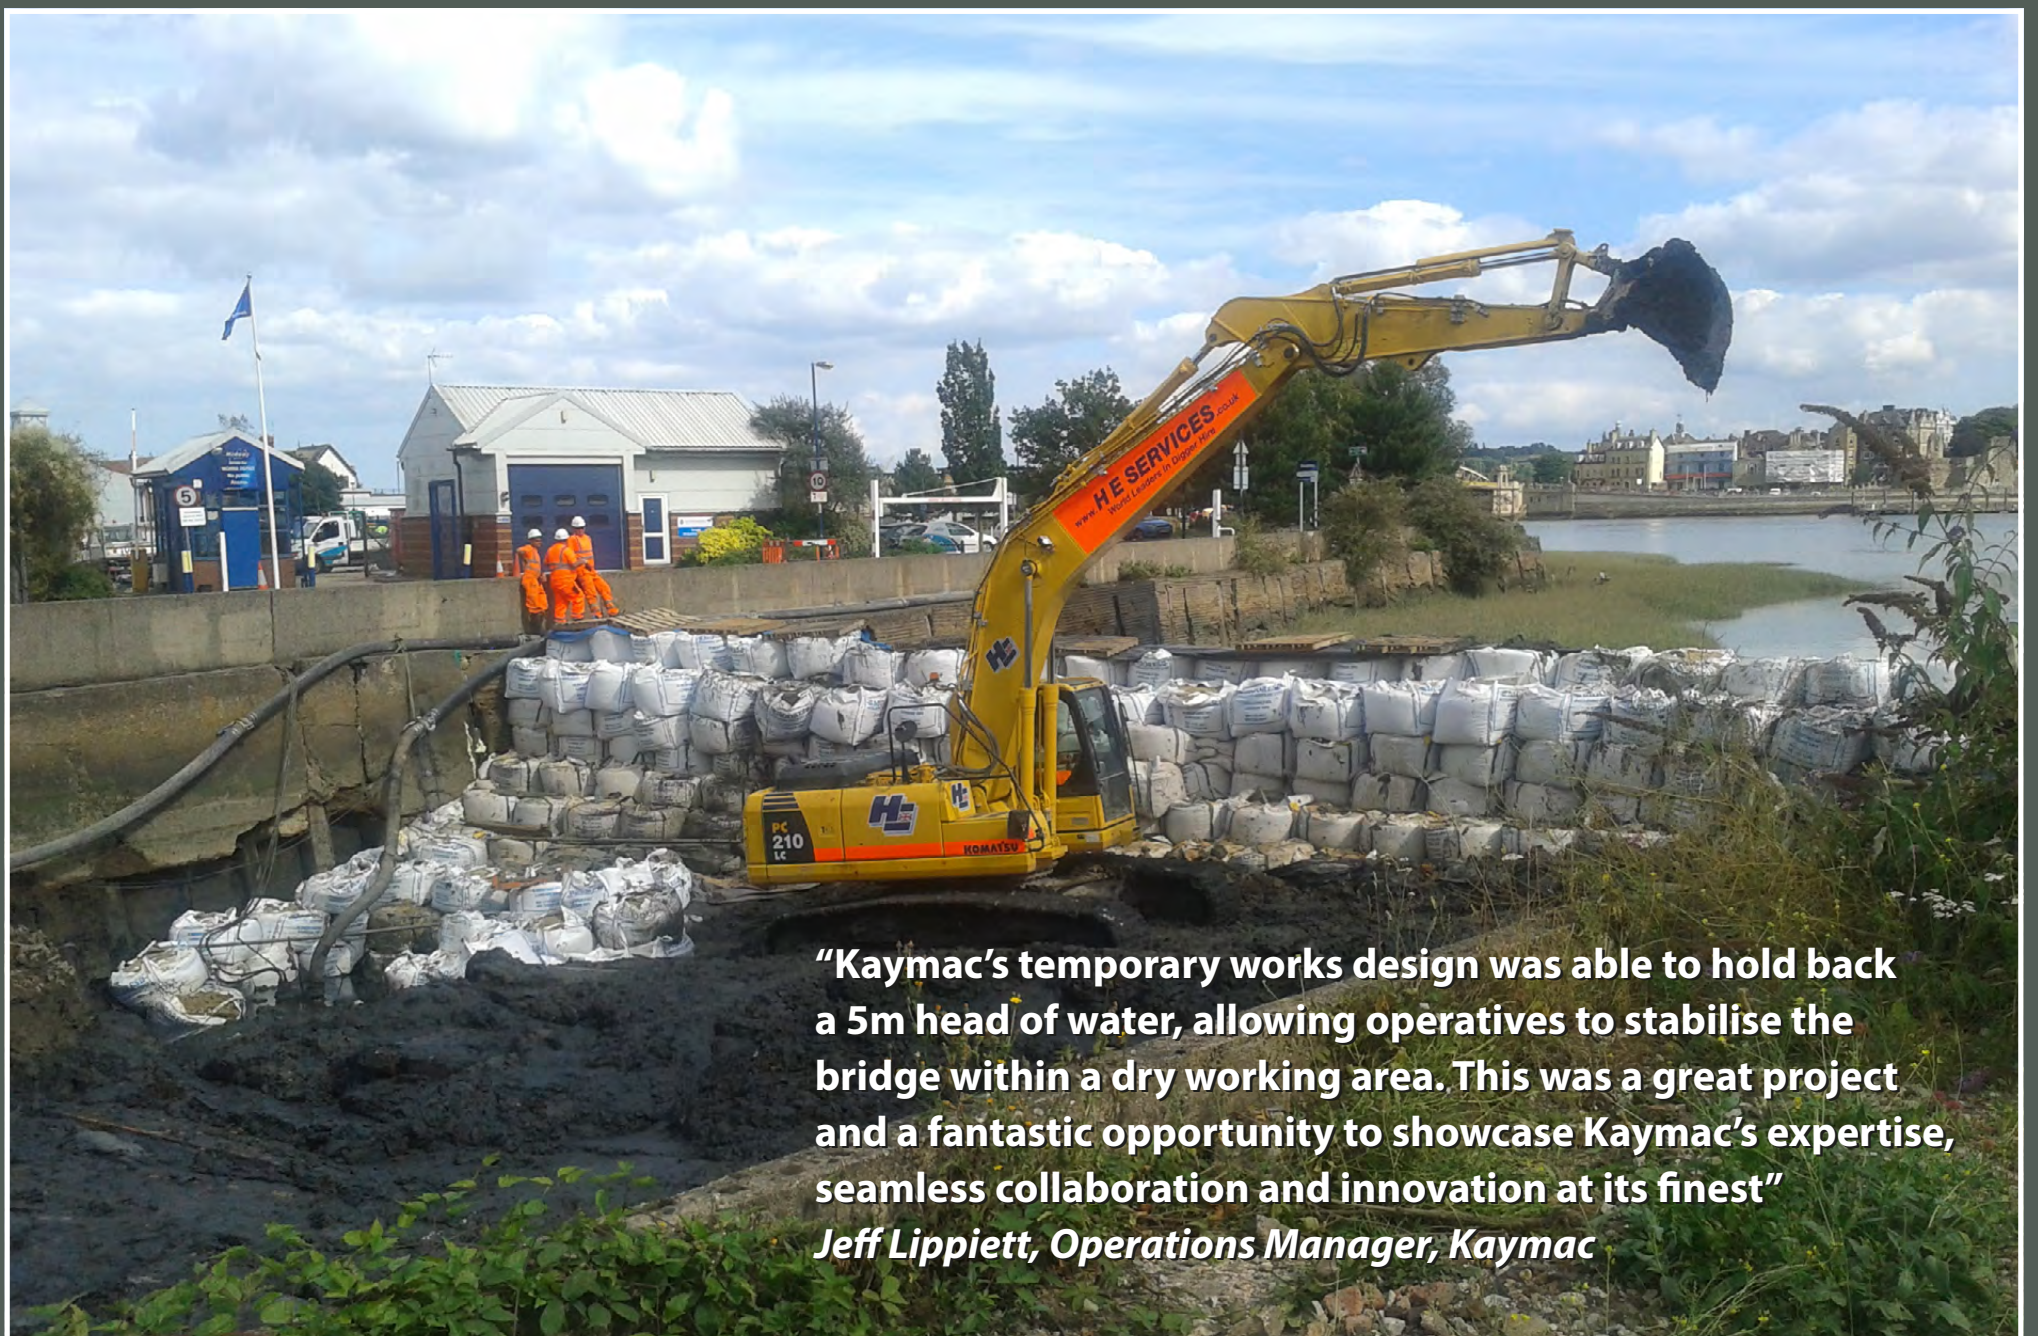
The bridge structure was deemed unsafe following investigation due to rotation and movement; the structure required stabilisation. The works comprised of Bridge Strengthening works including insitu concrete to the invert, 42m long ground anchors and all associated temporary works

The total bridge length is 57 metres, with four spans of 10 metres and a longer centre span of 17 metres. The total width is 8 metres. The substructure is believed to date from 1856, with the superstructure being a later deck replacement circa 1900. The substructure had a history of movement and appeared to have been repaired on several occasions. The piers adjacent to the creek had rotated and Pier 1 had been propped by a brick supporting wall which had subsequently cracked. The substructure therefore required stabilization.

The substructure stabilisation works involved restricting further piers (Piers 1 and 4) comprised of the installation of 5 no ground anchors per pier. These anchors were driven down from horizontal to the design level and angle.

The second stage of the works was to stabilise the two central piers (Piers 2 and 3). This was achieved by excavating at the toe of the existing piers, and installing a concrete slab that prevented further movement of the pier bases inwards.

Due to the lack of head room under the bridge we were unable to install a temporary sheet piled cofferdam as proposed, instead we opted to use 1 tonne dumpy sand bags stacked up to create a temporary bund. An excavator was used to place the 1T dumpy bags at low water to the upstream and downstream ends of the structure. Once positioned, polythene sheeting was placed over the bund and held tight using smaller sand bags to create as dry working area as possible.

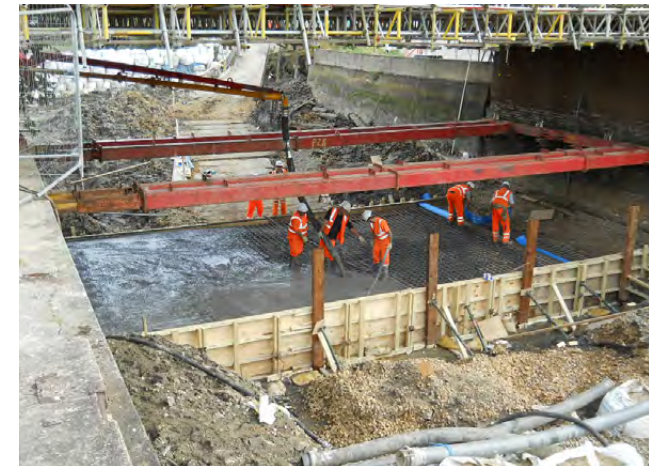
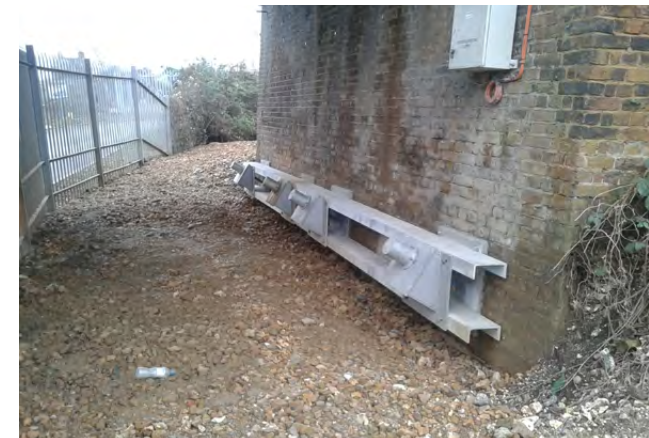
Waling beams spanned between the inner faces of Piers 2 and 3 and at intermediate points, RMD Megashore struts were used to provide temporary support to the piers prior to the excavation of the creek material.

Following the installation of the waling beams; excavation, formwork, steelwork and concrete works could take place safely.

To summarise, Piers 1 and 4 were stabilized by the installation of ground anchors with nominal tensioning. These were designed to resist further movement, however did not jack the piers back to their original orientation. The foundations of Piers 2 and 3 were stabilised, this involved the installation of a reinforced lightweight concrete, cast in-situ slab at the base of the piers which spanned under the existing creek bed. The slab is 750mm deep and placed on a 500mm deep stone bed, and connected to the base of the piers with stainless steel dowels.

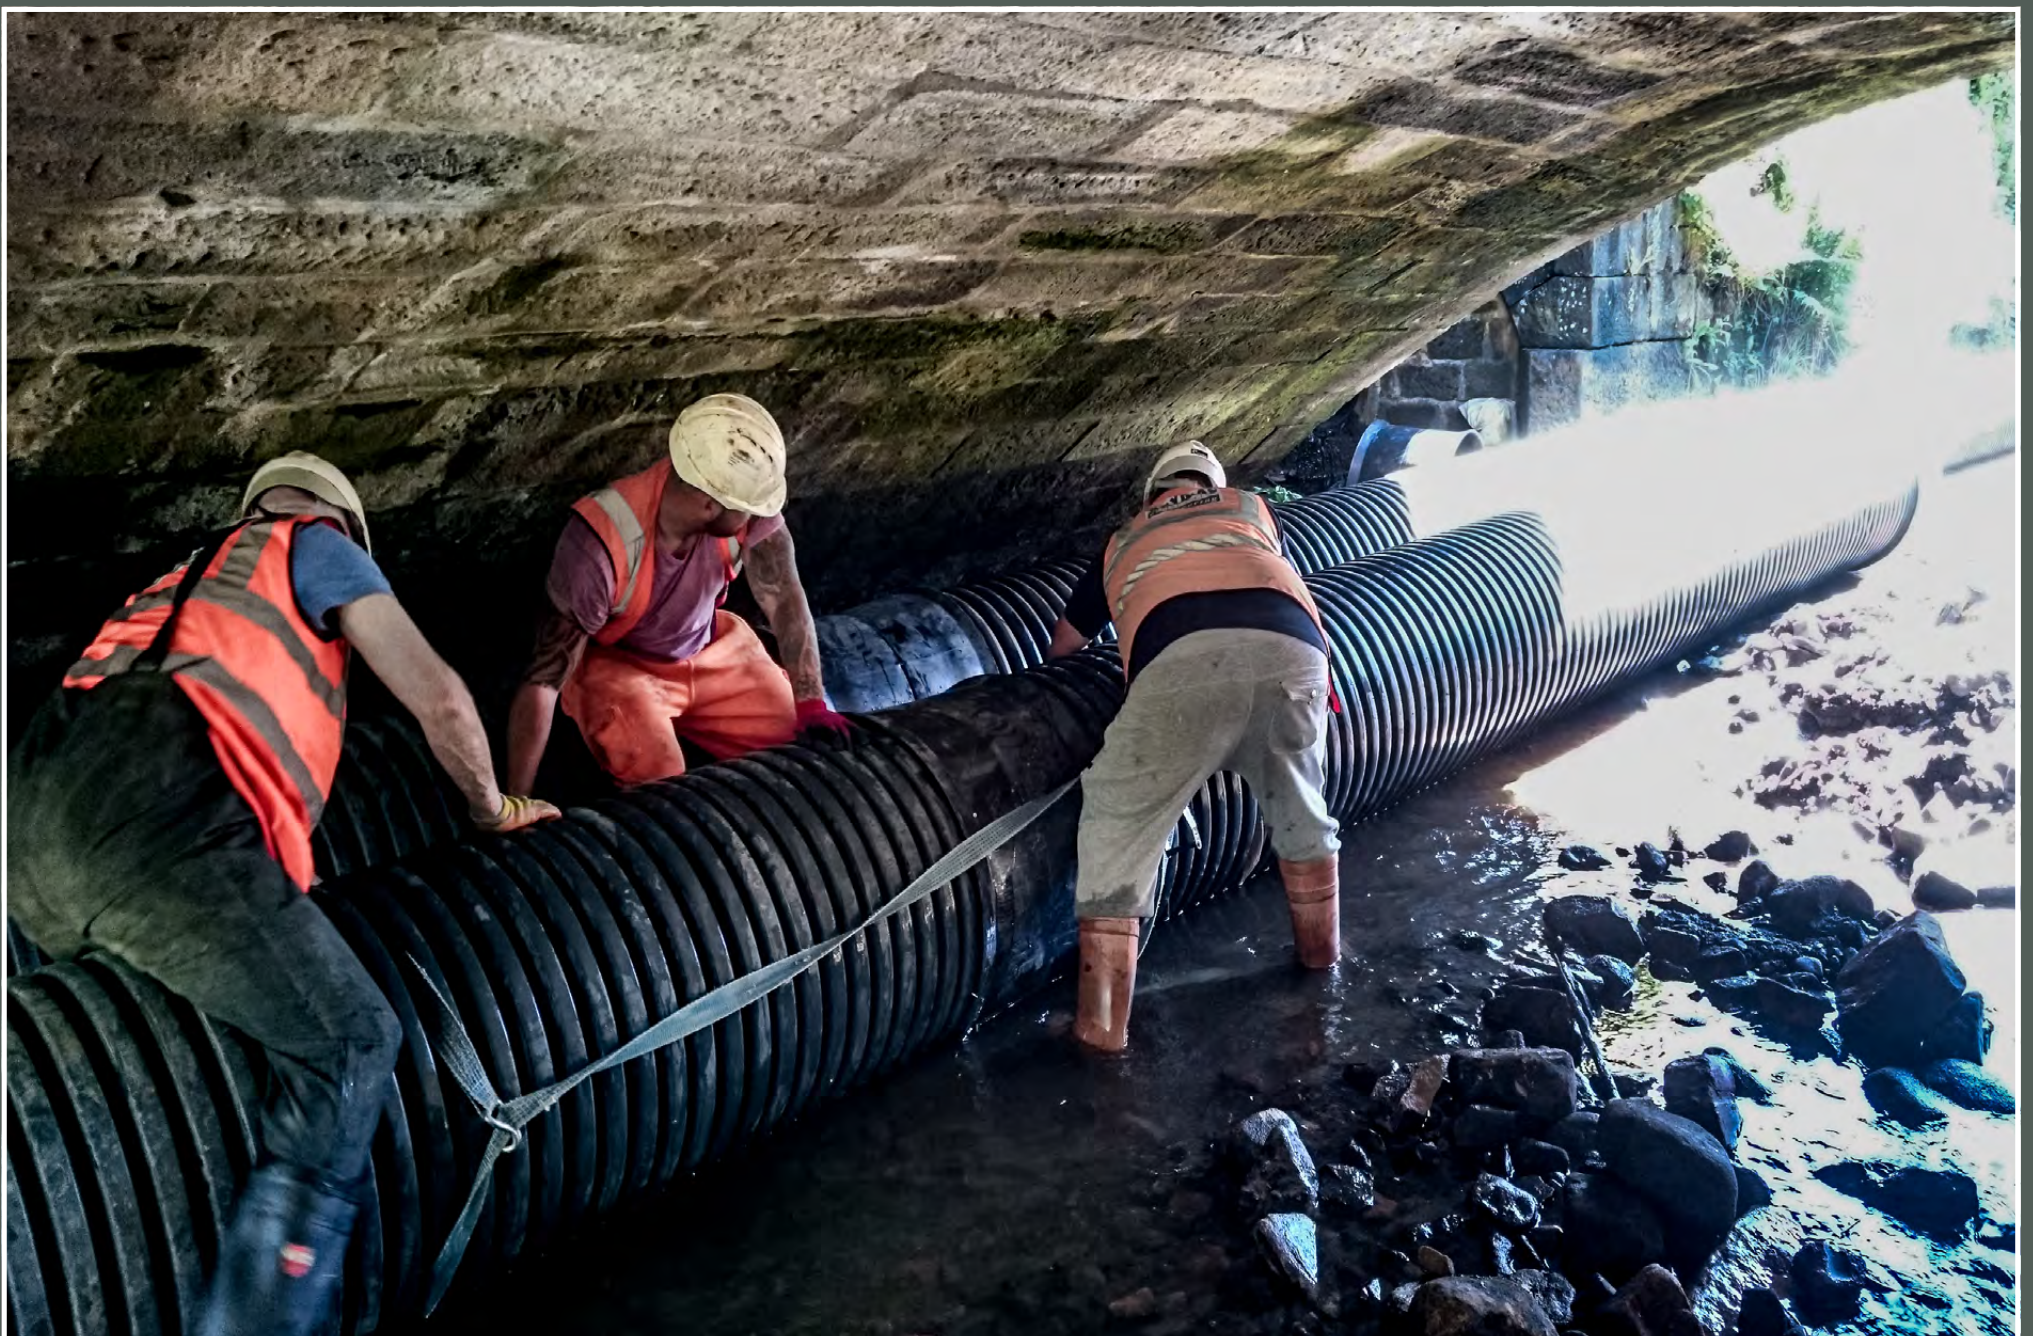
Lack of headroom due to a build up of bed materials, and the potential for scour damage during flood conditions required flood alleviation works for our Client, Calderdale Metropolitan Borough Council

To allow semi-dry access below the bridge structure, the river was flumed through two twin wall pipes. A dam of bulk bags of sand was then constructed upstream and downstream of the bridge to divert the flow through the flume pipes.

With the river flows were diverted, the bed materials were excavated down to formation level beneath the bridge and 6m upstream and downstream of the structure to allow placement of the Proserve scour protection Mattresses. Care had to be taken not to undermine the bridge foundations or the footings of the adjacent retaining walls. A total of 120t of mobile bed material was moved from below the bridge to increase the headroom and achieve the formation levels as per the design.

Once the levels had been reduced, the scour protection could be installed onto the prepared river bed. The scour protection consisted of 220mm thick Proserve constant thickness mattresses, which were filled with a 2:1 sand/ cement ratio C35 micro-concrete. An underwater additive was mixed with the micro-concrete to prevent wash out and consequential pollution to the river. Environmental protection mitigation filter screens were placed downstream of the works to reduce the impact of pollution entering the river.

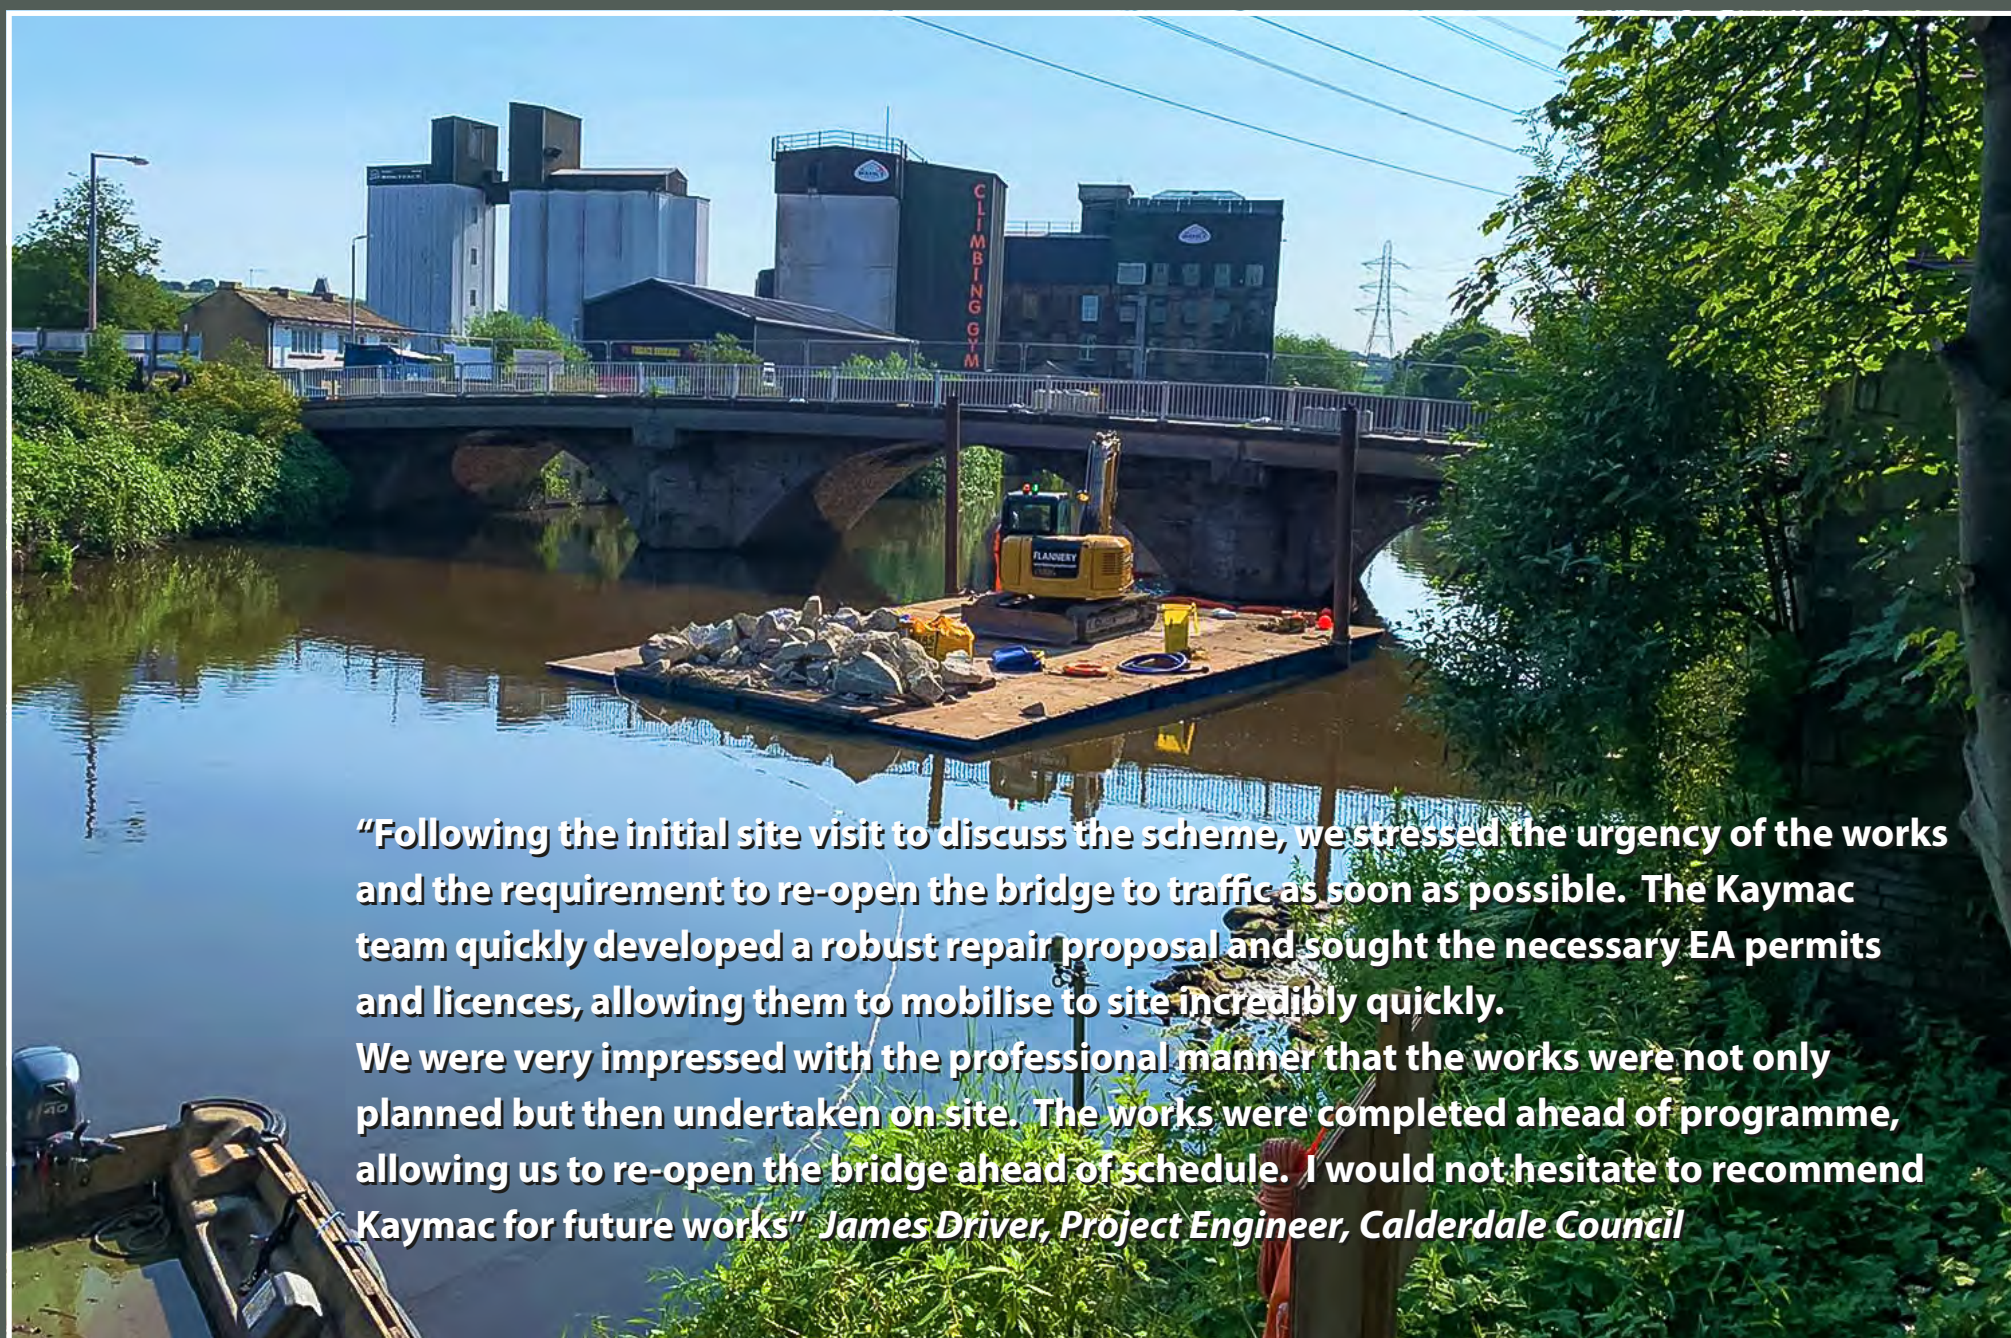
Rastrick Bridge is a three-span underbridge which carries the A643 over the River Calder. The structure is constructed from bonded masonry abutments and piers that support bonded masonry arches

Following the severe flood conditions experienced across the U.K in early 2020, critical safety checks to infrastructure have been of paramount importance. In this particular case, the flooding had transported a shipping container causing it to become wedged against the upstream face of the bridge structure which could not be removed until the river levels had subsided. Its wedged position had caused severe scouring to occur to the affected pier.

Upon mobilising to site, Kaymac installed a temporary access ramp to safely construct the pontoon system within the watercourse. Through diving operations and with the assistance of the excavator, the loose bed material around the pier was excavated

A concrete boom pump positioned off the bridge (to ensure no additional loading was applied) was used to place an approved underwater concrete mix, essentially filling the scour hole and stabilising the structure. The excavator was then used to place rock armour around the cutwater of the pier to offer further protection against future scour. All elements of the works, including the installation of the temporary and permanent works through diving operations were undertaken by Kaymac's directly employed workforce.

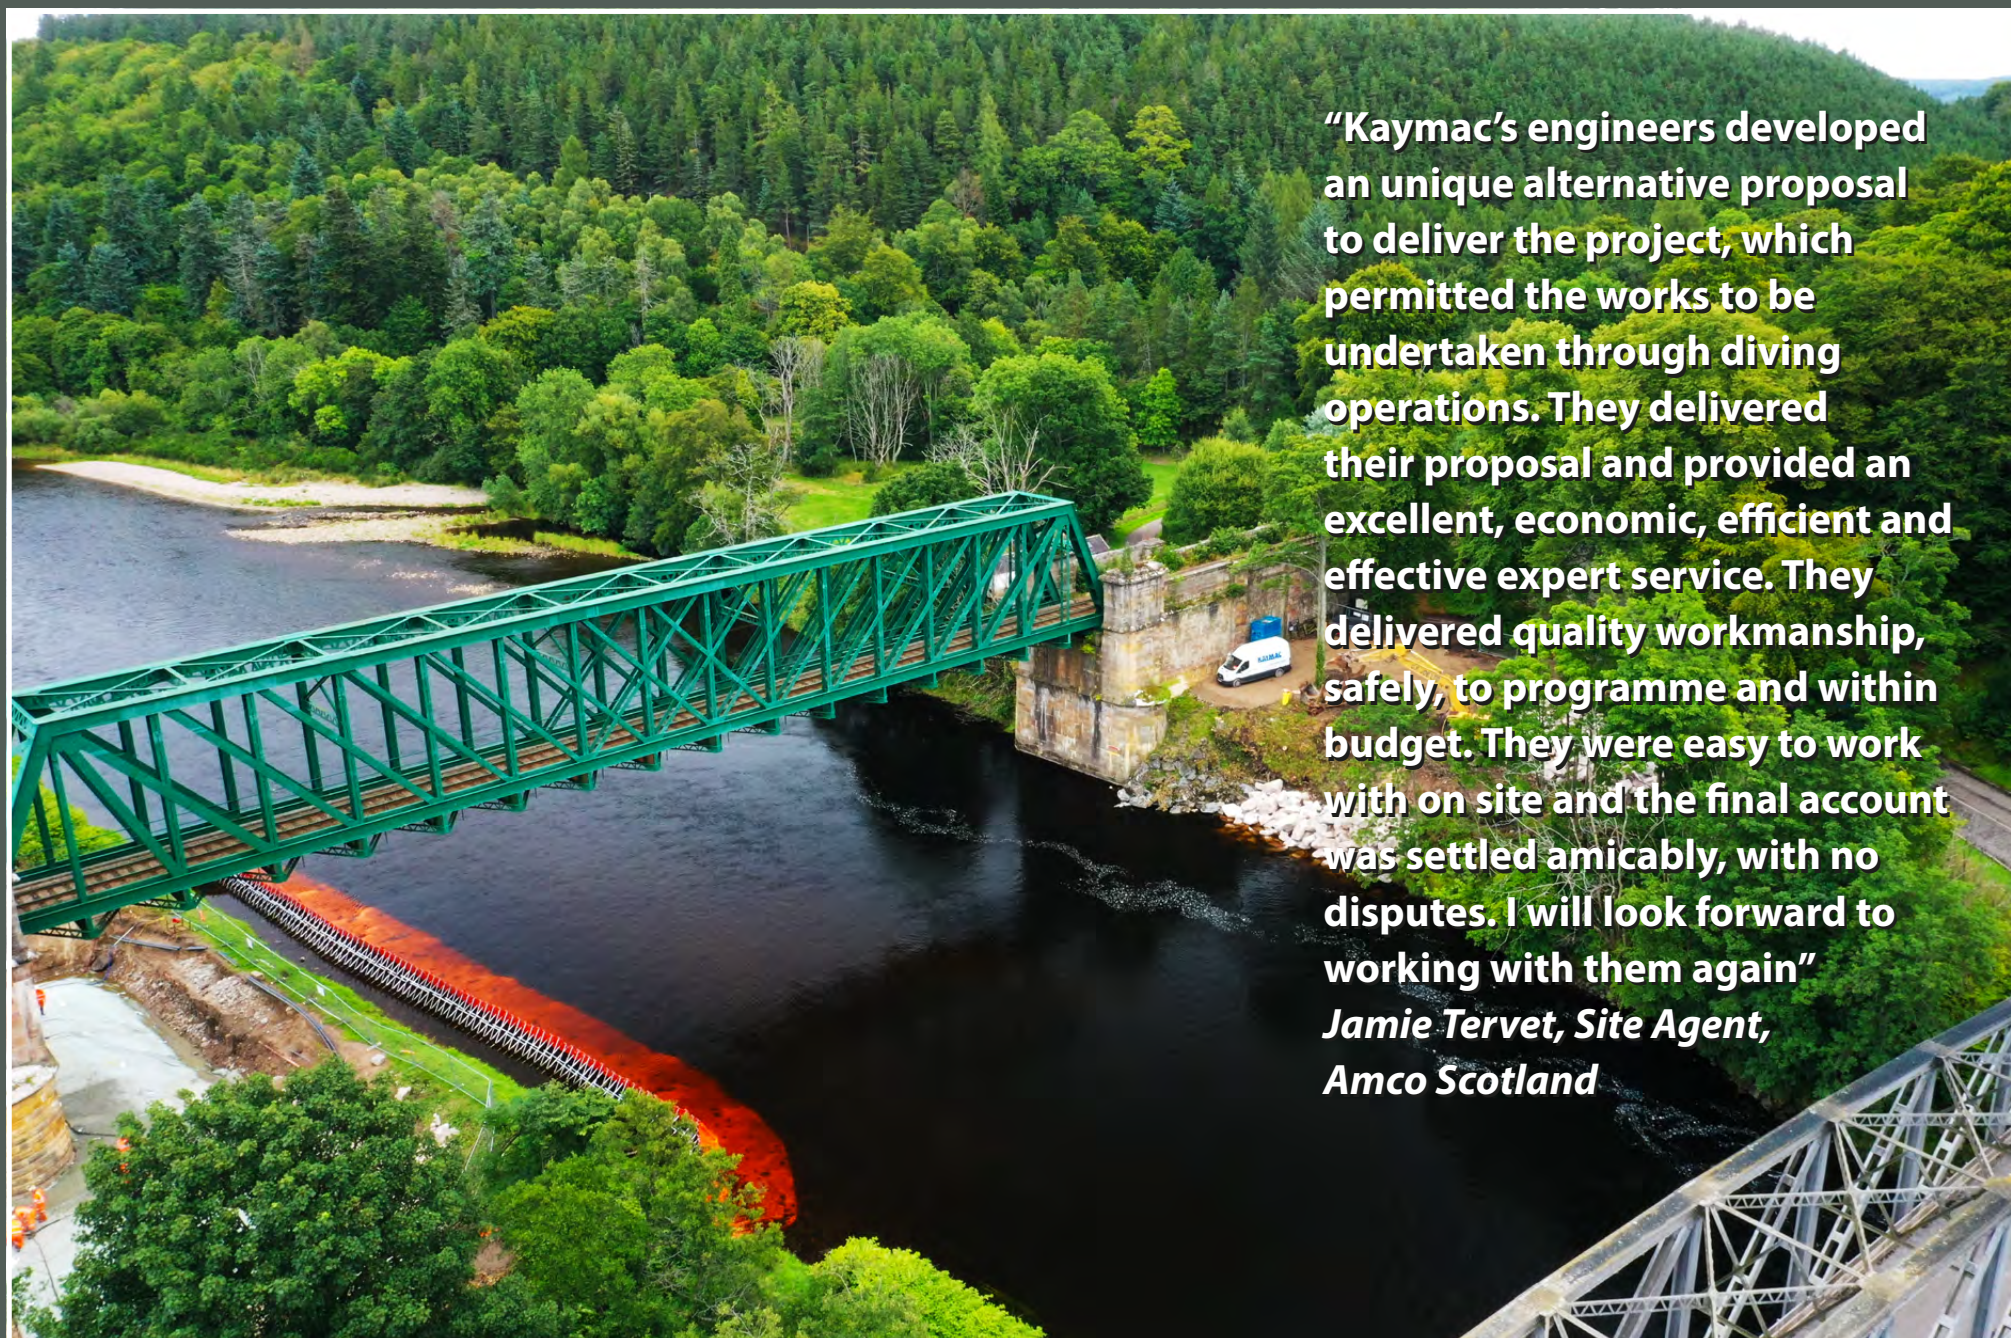
In late July 2020, Kaymac were contacted by our client to assist with developing a proposal that would permit the safe installation of a fabric formwork scour protection system to the abutment of a railway bridge near Inverness, Scotland

The client had secured the scheme and planned to undertake the works in dry conditions using a portable frame dam system; however, it became evident that this would not be feasible given the approximate river depth of 3.0m in certain sections. Following the site visit, Kaymac's engineers developed an alternative proposal which would permit the undertaking of the works through diving operations, without adapting the detailed permanent works design which would have likely resulted in the works being delayed until the following Spring, 2021.

Kaymac were confident that they could deliver a bespoke underwater solution and further developed the proposal through close liaison with the client's permanent works designer and the manufacturer of the fabric formwork mattress system. Kaymac were able to illustrate to the client that a number of value engineering principles could be implemented, including utilising the existing rock armour material that was on site and due to be used for the permanent works, into forming a temporary bund that would protect our diving operatives from the river flows during installation.

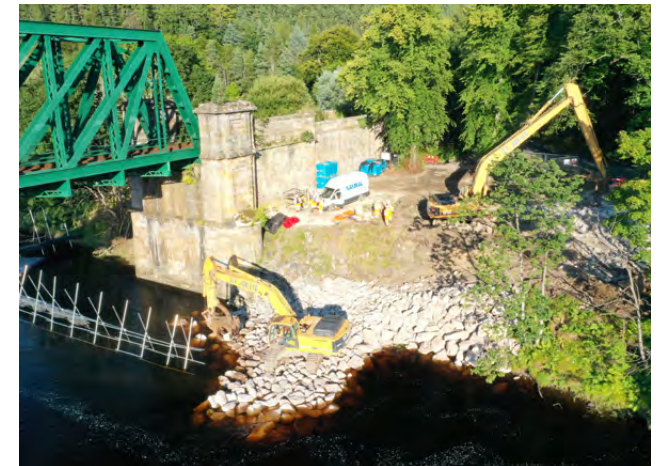
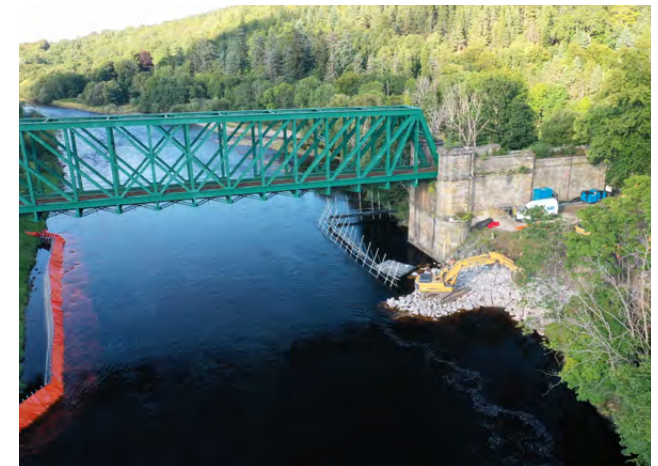
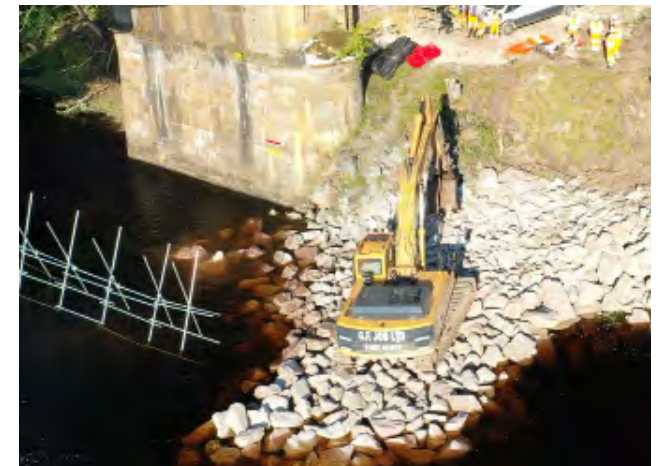
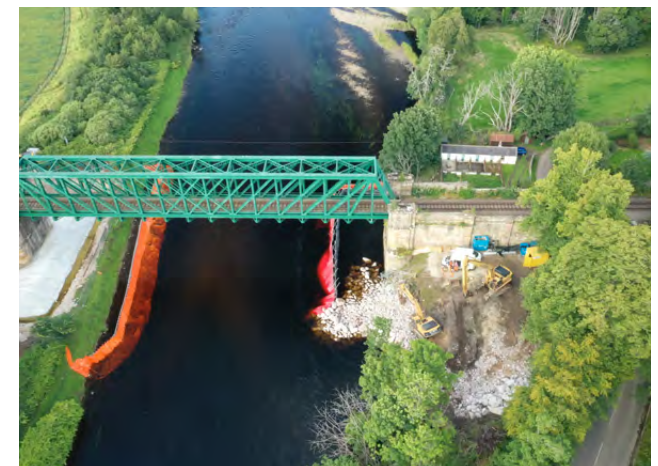
Undertaking the works below water also introduces a host of testing and quality concerns, however, with Kaymac's vast experience in undertaking these projects across the UK, a detailed Inspection & Test Plan was documented and further, adhered to on site to ensure compliance at every phase of the works. Following the successful completion of the permanent works and subsequent removal of the temporary measures, the worksite was handed back to the client, two weeks ahead of programme. ●

All elements of the works, including the installation of the temporary and permanent works through diving operations were undertaken by Kaymac's directly employed workforce. Our delivery management team included a qualified and experienced on-site project agent, together with regular visits from one of our project engineers to ensure that the works were undertaken in accordance with the detailed design.
