# SOLUTIONS TO CORROSION IN RAAC PANELS

**Concrete Preservation Technologies (CPT)** has been undertaking research on RAAC for four years with its partners in the NHS, independently at its laboratories and as a part of the prestigious Loughborough University RAAC Research Group. CPT has been focusing on the inspection, testing and corrosion risk appraisal of RAAC panels. **Christian Stone** reports.

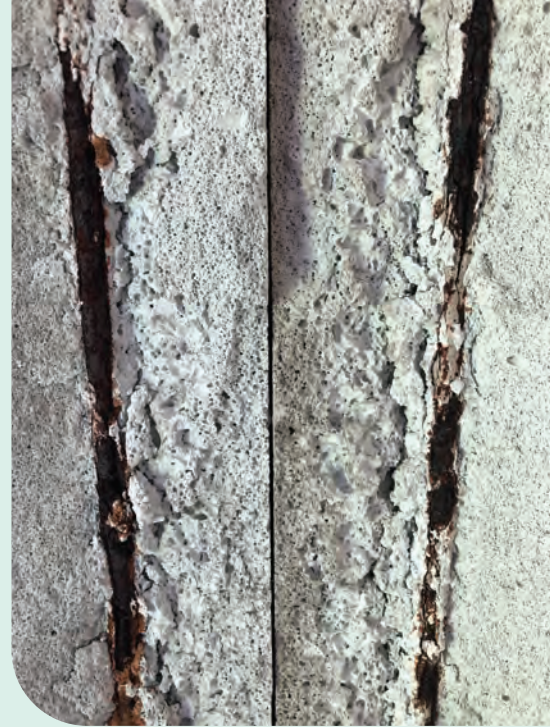
Figure 1 – corrosion under the surface.

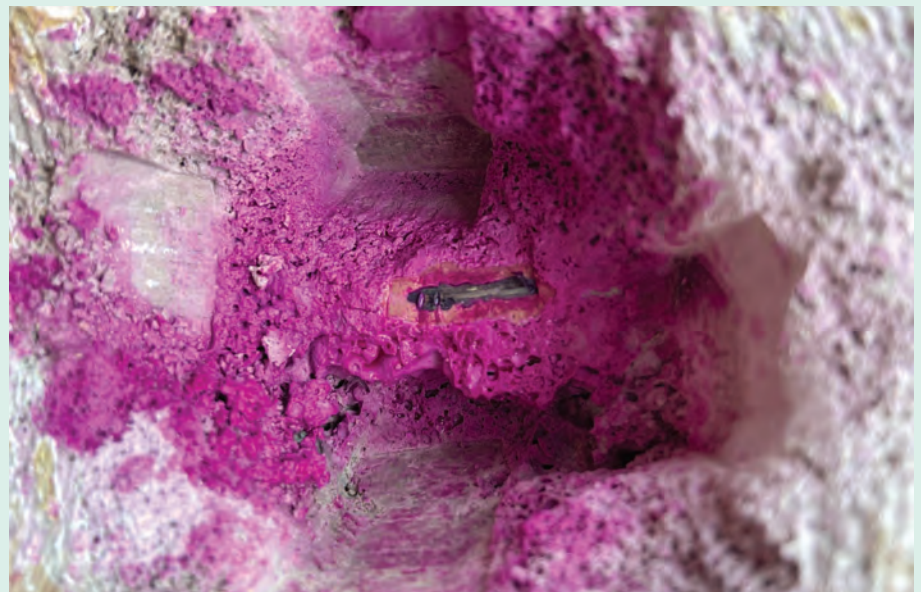
Figure 2 – realkalisation confirmed with the application of phenolphthalein solution.

CPT has been working with partners in the NHS for years to develop corrosion management solutions for RAAC. RAAC-Guard, a hybrid corrosion management solution has been implemented that is initially powered to reallocate the environment around the steel and halt any ongoing corrosion. Once the corrosion has been halted, zinc anodes are connected to the reinforcement within the RAAC. Being more electrochemically active, the zinc anodes corrode sacrificially to provide a reactive current, which delivers protection proportional to the amount of moisture and heat present. Any future water ingress will cause the anodes to corrode preferentially, delivering protective current to the steel and maintaining its passivity into the future.
