CP6 Footbridge Refurbishment Framework

Woolwich Dockyard Station Footbridge – Refurbishment & Strengthening

East Croydon Station Link Footbridge – Dilapidation Survey & Feasibility Study

Kearsney Station Footbridge Feasibility Study

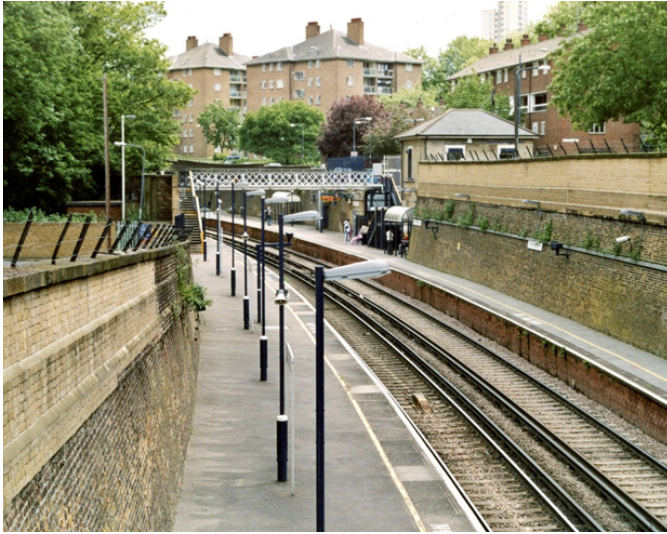
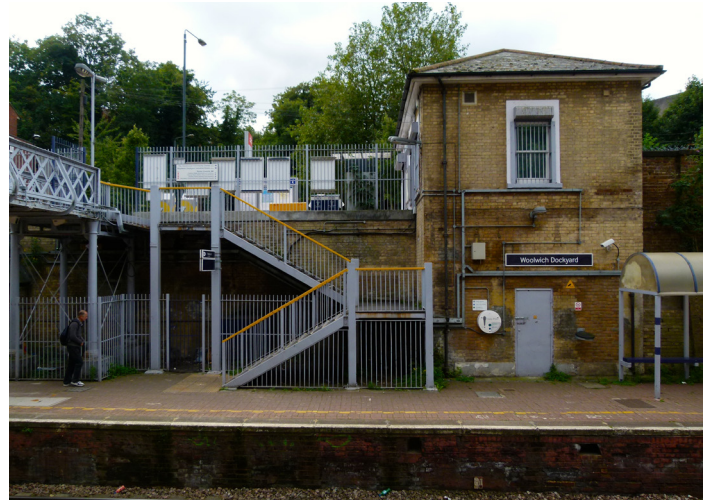
Woolwich Dockyard railway station is in Woolwich in the Royal Borough of Greenwich and has been servicing passengers since 1849. The scheme was to strengthen and refurbish the undercapacity and dilapidated footbridge and associated staircases to provide a maintenance free design life of a minimum 15 years.

The footbridge required strengthening of the main span truss top and bottom chords. The client initially proposed strengthening by using additional steel plates, which would have required excessive amounts of material. However, due to the logistics of installing these during possessions, it became a complicated and uneconomical proposal.

Based upon our experience of these types of structures, we recommended a more efficient option would be to reanalyse the footbridge, taking into consideration additional and strengthened u-frame restraints.

Using a structural analysis programme, Autodesk Robot, we modelled the entire footbridge and were able to design the optimal size and number of u-frame elements, without significantly increasing the overall weight of the footbridge or altering the overall appearance of the structure.

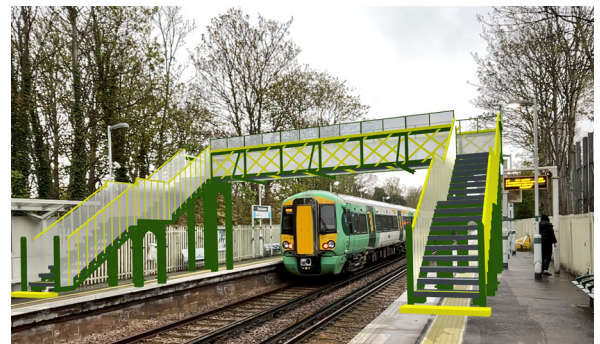
The footbridge is a single span structure; the main span is formed of wrought iron lattice main girders with transverse cross girders and outriggers with a timber deck, and the staircases comprise cast iron stringers supporting timber treads, and landings supported by cast iron angle column trestles.

Optioneering was undertaken at an early stage to ensure the existing appearance of the structure was maintained, without altering or detracting significantly. The team used 3D design software to model the different feasible options, allowing the Client to make an informed decision on their preferences.

For our presentation of the proposals, augmented reality software was used to share with the asset owner the proposed refurbishment and strengthening alterations to the footbridge, illustrating how the appearance would change to help facilitate their approval.
