Whiteadder Bridge

Location
Berwick, UK

Structure
Single Carriageway Bridge Over Estuary

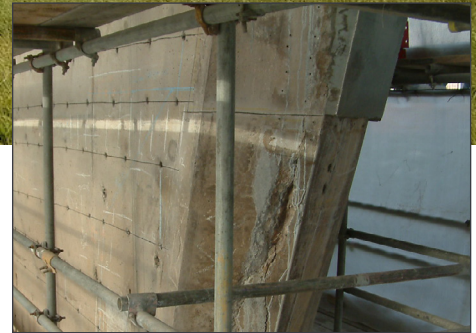
Substantial areas of spalling/loose concrete were visible along with salt deposits in certain areas. In addition to the main substructure, specific areas of the underside of the bridge deck had had been contaminated with significant levels of chloride salts.

Visible spalling and loose concrete

CPT designed a DuoGuard™ 500 hybrid anode system to halt ongoing corrosion and prevent further damage to the contaminated piers and abutments. Using an external power source, an impressed current was applied to stop active corrosion and render the steel passive. The anodes were then disconnected from the power source to self-generate a galvanic current, sufficient to maintain steel passivity and control corrosion.

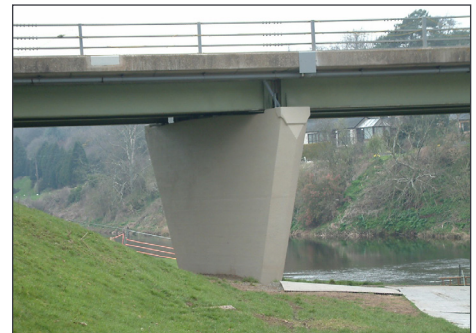
Finished pier 10 years after installation

Corrosion related deterioration of Whiteadder Bridge has been halted. After the initial power up period using an external power source the DuoGuard system is self-powered thus minimising future maintenance requirements and associated life costs.
