# Greyhound Bridge

Location  
**Lancaster, UK**

Structure  
**200m long road bridge over the River Lune**

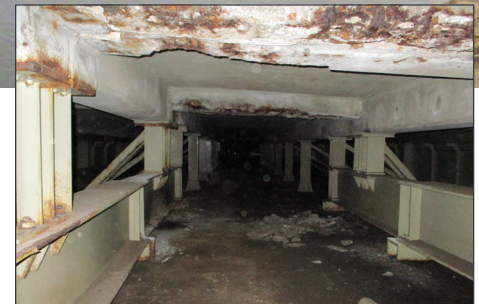
The bridge joints had deteriorated leading to water ingress and chloride induced corrosion of the congested steel reinforcement within the transverse beams of the superstructure. As corrosion is expansive in nature, this resulted in significant cracking and spalling of the concrete cover.

Spalling transverse beams to soffit under deck joints

Hydro-demolition was used to remove the chloride contaminated concrete from around the joints. The concrete was re-cast incorporating RebaGuard galvanic anodes, which were fixed directly to the steel reinforcement, and new joints were installed. Should any water breach the new joints and soak the adjacent concrete, the sacrificial RebaGuard anodes will corrode preferentially and prevent rebar corrosion initiation. RebaGuard anodes with a high zinc mass were selected to reflect the high steel density and provide long term protection to the joint section.

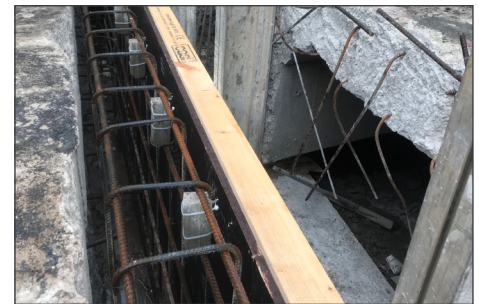
RebaGuard anodes in position ahead of concrete pour
