HEMPYARD HISTORIC BRIDGE

Historic building conservation, structural repair and strengthening

Hempyard Bridge is a three span historic masonry arch structure carrying a Public Right of Way (Bridleway) over the Black Bourn River just to the West of Ixworth. The central span is 4m, with 1.4m span side spans.

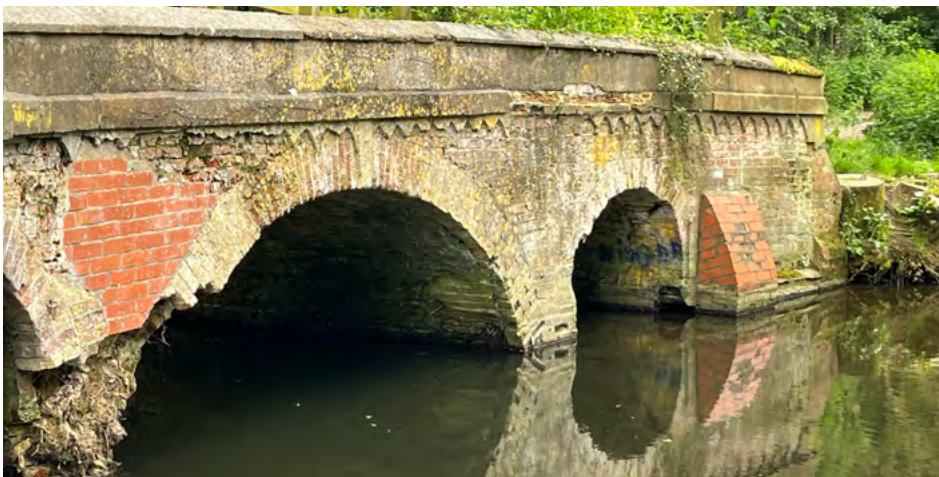
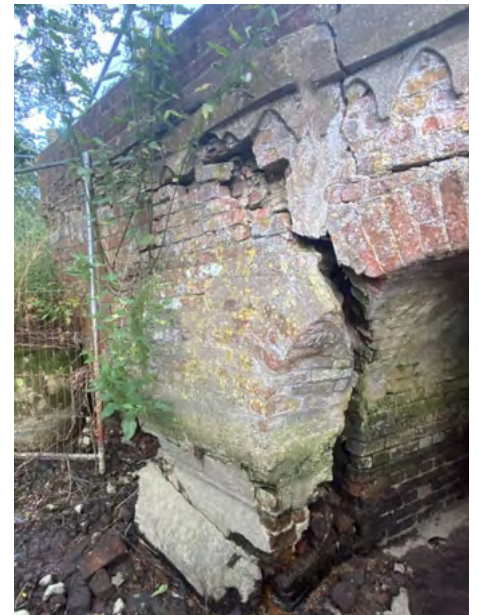
- ✔ Wing wall bulging
- ✔ Scour under foundation
- ✔ Masonry loss up to two bricks thick
- ✔ Roots embedded in the brickwork
- ✔ Sizable cracks throughout the arches and various joints
- ✔ Heavily spalled brickwork
- ✔ Damage to render
