GRP Segmental Culvert Lining at Farthinghoe

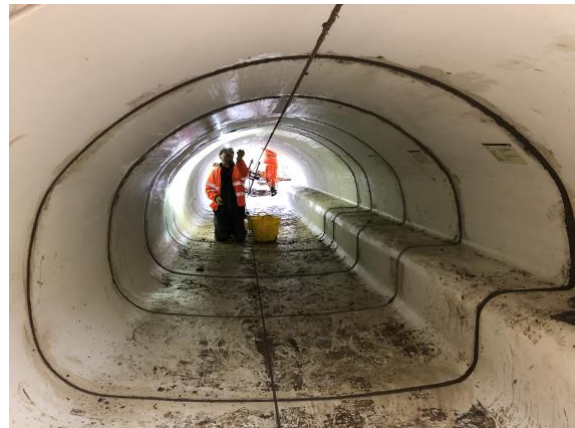
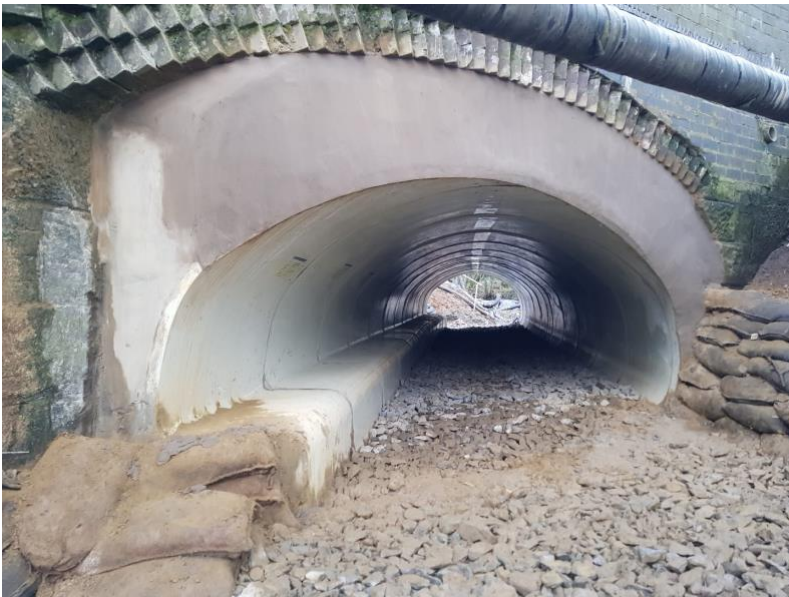
The bridge was constructed of a skew brick-arch section which had previously been repaired, but this was now failing, along with signs of radial cracking occurring. The bridge had been extended in 1971 with a corrugated steel arch which was also now showing signs of corrosion. The structure is shallow, 15m long with a flat invert and straight walls, which arches across to a height of 1816mm with a span of 3000mm.

Due to operational restraints on this structure, a GRP segmental lining process was chosen to be the most cost-effective, non-disruptive and reliable solution with over 100 years of design life. The GRP units had to be designed to be fully structural standalone units to take all the loadings imposed up to 40t using the LM2 Eurocode design specifications.

Working with our partner Channeline (manufacturer of GRP units) a profile with a 48mm thick liner was designed & proposed. This was initially accepted. However, following discussions with the EA, a requirement to accommodate safe movement of mammals/otters through the new structure was required. The profile of the GRP liner was then modified to accommodate a 500mm ledge/shelf to accommodate wildlife movement through the final structure.

The river bed was dug out and a new gravel bed laid by the client prior to iLine installing the segments. The team then grouted the GRP units into place, all within a 2-week period.
