## CASE STUDY – GRP Lining, Old Vic Culvert, Sicklesmere

Old Victoria Culvert is a single span brick-arch with a concrete extension carrying a tributary of the River Lark beneath the single carriageway A134 (Sudbury Road) and private gardens located between Sicklesmere & Great Whelnetham in Suffolk.

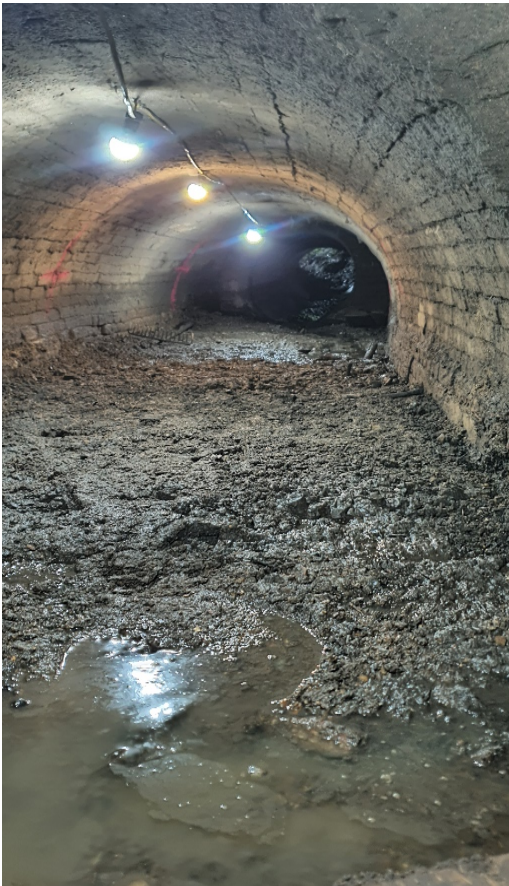
As with many old brick-arch culverts it has differing cross sectional areas with a width of 1.72m x 1.07m high for the first 34m including 6 bends, which then changes from the flat bottom brick-arch into a 1.2m diameter circular concrete pipe for the last 10m. Overall length of the culvert is 44m.

Repairs to brick-arch had previously been carried out. However, the concrete pipes had significant cracks in the crown and was badly deformed caused by settlement of the pipes and there was evidence of scour to the invert. Overall, the structure was considered in danger of possible collapse.

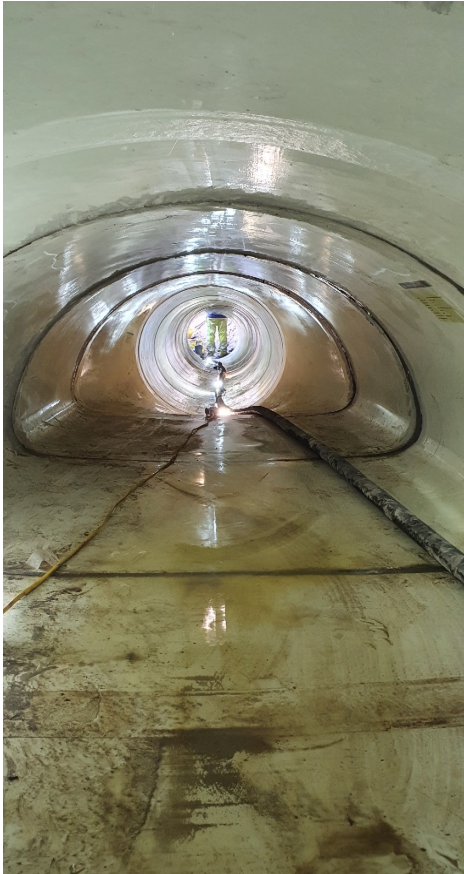
Following discussions with the Suffolk CC flood team to ensure maximum flood capacity, it was agreed to lower the invert in the arch section by digging out the soft silt and gravel to enable a larger liner to be installed achieving a greater storage capacity. Flow calculations

confirmed that due to the Manning coefficient of friction an increase of 110% of the original capacity was achieved.
