# Rejuvenating your infrastructure assets

Latest Metrail projects

M180 Concrete Road Refurbishment	4-6
A180 Concrete Road Refurbishment	8-11
Tinsley Viaduct Concrete Repair & Waterproofing	12-13
Rochester Bridge Concrete Repair, Joint Replacement & Waterproofing	14-17
M621 Joint Replacement	18-21
M62 Lofthouse Joint Replacement & Waterproofing	22-23
Croydon Flyover Joint Replacement	24-25
London Bridge Refurbishment	26-29

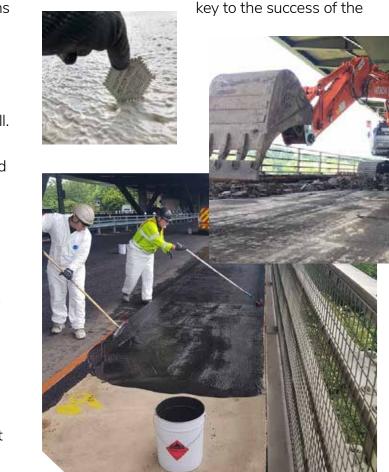
Employing a large Caterpillar tracked scraper with a bladed head, the first thing we did was remove as much of the remaining surface as possible before fine milling to remove any remaining traces of the old surface. We then carried out an extensive number of concrete repairs using Metaset Rapid Repair Mortar which cures to full strength in 1–2 hours. Next up: sand blasting the surface and carrying out adhesion testing. We then primed the surface and manually sprayed it with the ELIMINATOR® system. Rather than screeding the steel walkway – a method that had proved time consuming and costly – we proposed using Safetrack. After stripping and cleaning the old walkway surface down to the bare steel, we then primed and waterproofed it with ELIMINATOR® so that Safetrack could be applied.

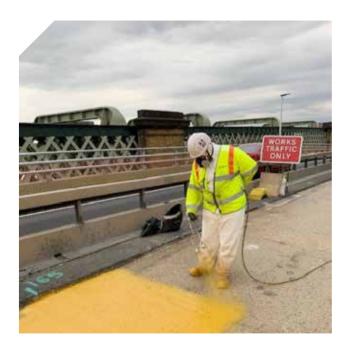
Execution - When it comes to replacement of the joints, damaged areas need to be cut out and all exposed surfaces primed before the Sentinal EMR rails can be lifted into place. Polystyrene shuttering was used before pouring the nosing mortar which was levelled with the road surface. Safetrack, a proprietary anti-skid finish, was then applied.

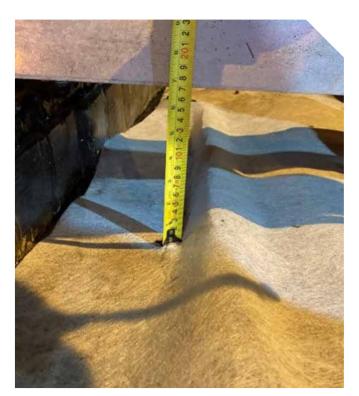
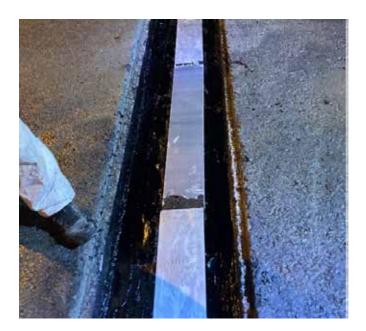
Old plates were then removed, and both the trench and the air gap were cleaned. Using the IKO PermaFLASH D300, we plugged the air gap and then applied a primer to all trench

surfaces. After the primer came a first layer of molten PSB, which is a highly flexible material used for tanking the trench. It was applied to the base of the trench, and a galvanised steel plate was placed in the trench. The trench could then be fully tanked out and we installed a drainage channel and rodding box.

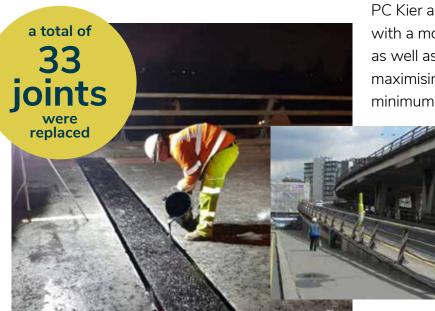
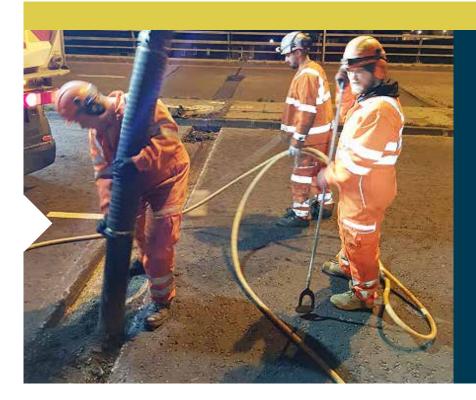
The joint material caters for +/- 20mm movement range (40mm total)

Each joint was 7.69 metres long, 550mm wide x 160mm deep

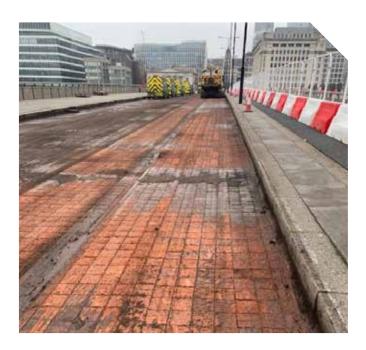
Following scraping of the old deck and fine milling, extensive concrete repairs are required on the exposed bridge deck to ensure the surface is clean, dry and structurally sound to allow application of a primer

On completion of the concrete repair work the GCP ELIMINATOR<sup>®</sup> waterproofing membrane is applied to provide a minimum dry film thickness of 2mm which equates to 2.8 kg/m<sup>2</sup>
