CASE STUDY – CIPP Lining under the A87, Isle of Skye

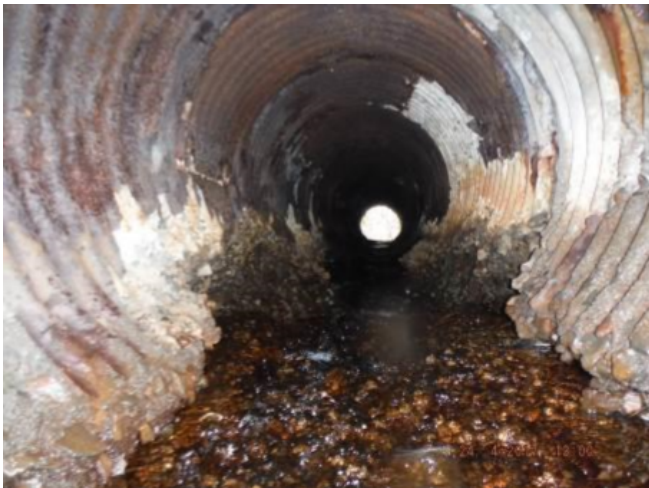
A 10m length of 900mm diameter ARMCO pipe under the A87 North of Sligachan was severely corroded and erosion of the concrete surround had made the culvert vulnerable to possible collapse.

Before Lining

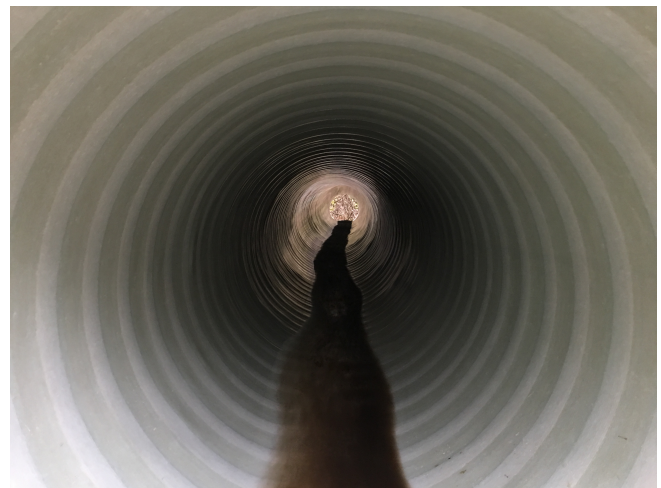
Installation of the liner was completed in 2 days during 2018, with only a single-lane closure during the work day was required. The liner installation was installed at a cure rate of approximately 1m/min and resulted in a fully structural liner with an increased flow capacity.

After Lining

A fully structural UV GRP cured in place liner capable of supporting all the loads imposed by LM2 of the Eurocode design specification was required. A liner thickness of 14mm was calculated by iLine's in-house design team and the bespoke liner, with a 120-year design life was ordered from our partners Reline Europe in Germany with a 3-week delivery lead-in period.
