Rejuvenating your infrastructure assets

Latest Metrail projects

M180 Concrete Road Refurbishment

A180 Concrete Road Refurbishment

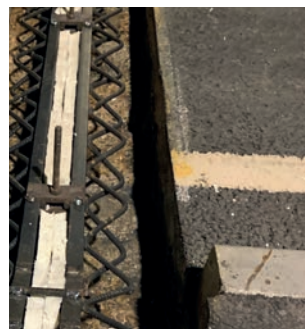
Technology - The majority of the joints replaced on the Old Bridge were Type 1, also known as a “plug joint”. Cost effective and maintenance free, the plug joint is a simple expansion joint for highway bridges. On the New Bridge, Type 6 joints were specified. Type 6 joints incorporate a central elastomeric seal inserted into two steel carrier rails. The carrier rails have special sinusoidal-shaped reinforcement welded into the rear face which locks the carrier rails into the nosing mortar.

Execution - When it comes to replacement of the joints, damaged areas need to be cut out and all exposed surfaces primed before the Sentinal EMR rails can be lifted into place. Polystyrene shuttering was used before pouring the nosing mortar which was levelled with the road surface. Safetrack, a proprietary anti-skid finish, was then applied.

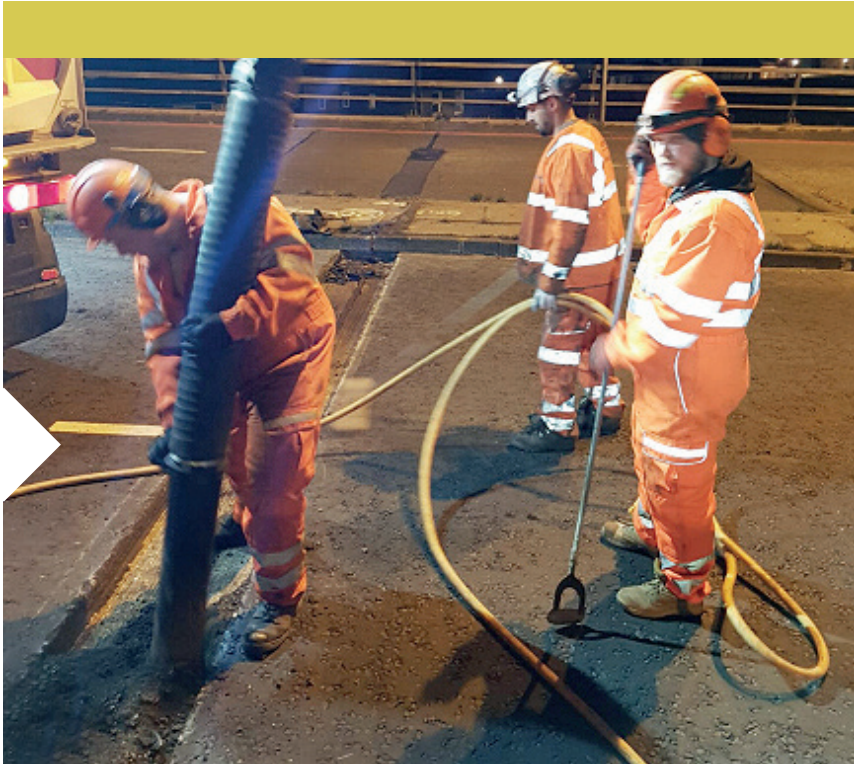
The joint material caters for +/- 20mm movement range (40mm total)

Each joint was 7.69 metres long, 550mm wide x 160mm deep
