**FIX CONCRETE CORROSION.  
FOR GOOD.**

**Markham Global working with Kier Construction, deliver a zero-maintenance, guaranteed concrete deck protection for Gloucestershire County Council's new mobility hub.**

# FIX CONCRETE CORROSION. FOR GOOD.

## APPLICATION FOCUS

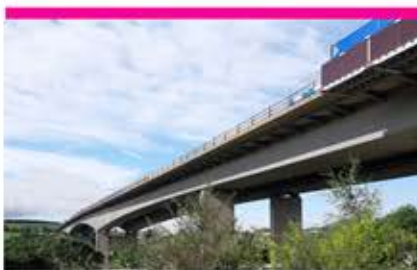
**FRIARTON BRIDGE**  
Perth, Scotland

AQURON 7000 colloidal silica hydrogel treatment was selected as an alternative to cathodic protection.

This provided not only protection of the steel reinforcing, but also the concrete itself to provide durable, corrosion-resistant concrete for this vital safety element of the bridge.

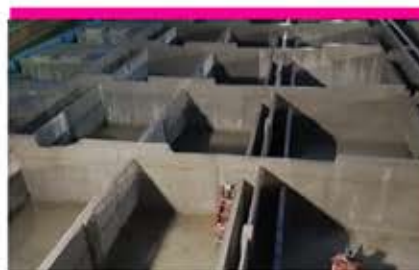
**WATER TREATMENT PLANT**  
Invercarnie, Scotland

The contaminating environment of water works is very challenging for concrete.

In this project, hydrogel treatments were applied during construction to give durability from day one.

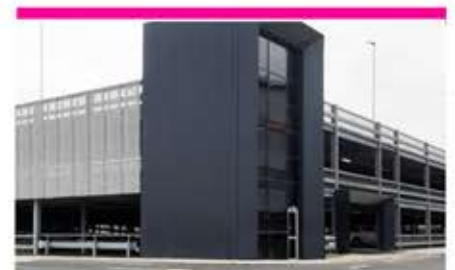
**DIRFT<sub>3</sub> MSCP**  
Daventry, UK

Buckingham Group chose to use Markham's TOPTECT system on the new build DIRFT MSCP.

All penetrations in the decks and upstands were sealed with CONQOR 47B waterstop gasket to provide a fully waterproofed (zero-maintenance) deck solution.
